DSOS404A-03A

# Modification Recommended Service Note

## DSOS404A – DSO Infiniium S Series 4GHz 4 channel

**The Problem** – Under certain circumstances a PLL2 error may occur on the S-series products.

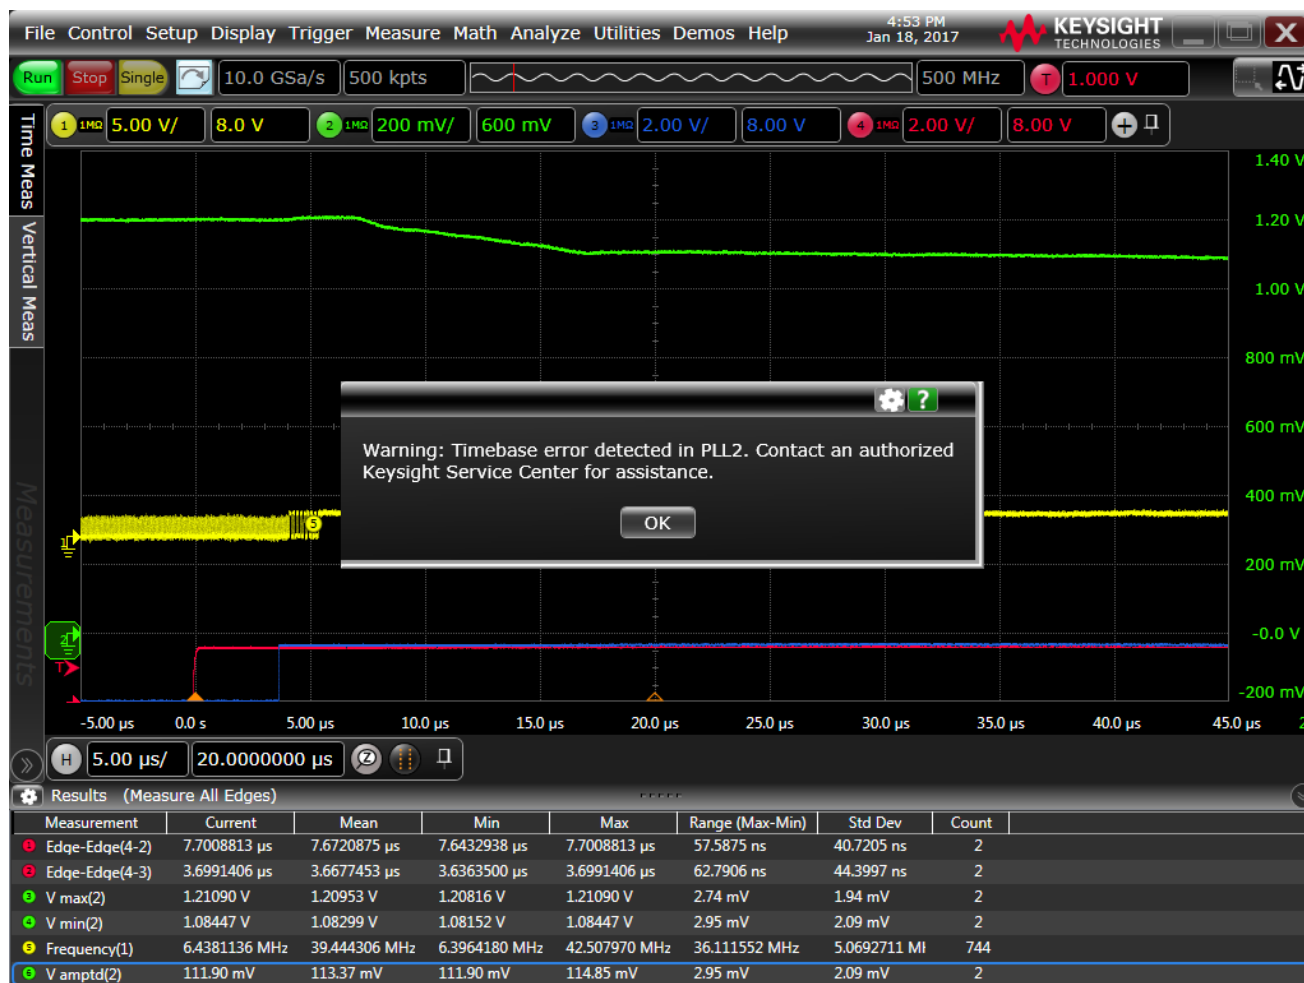
On the old acquisition board, 54911-66501/69501, a PLL2 error message sometimes occurs. The error message appears on the screen as below:

There is a new acquisition board available for the S-series scopes (54911-69511); any repairs associated with the older 54911-69501 needs to be replaced with 54911-69511.

1. Replace the acquisition board with the 54911-69511.
2. Save the Serial Numbers of the replaced and the new Acquisition Boards in Siebel. Please, follow this procedure:
