DSOS604A-03A

# Modification Recommended Service Note

## DSOS604A – DSO Infiniium S Series 6GHz 4 channel

**The Problem** – Under certain circumstances a PLL2 error may occur on the S-series products.

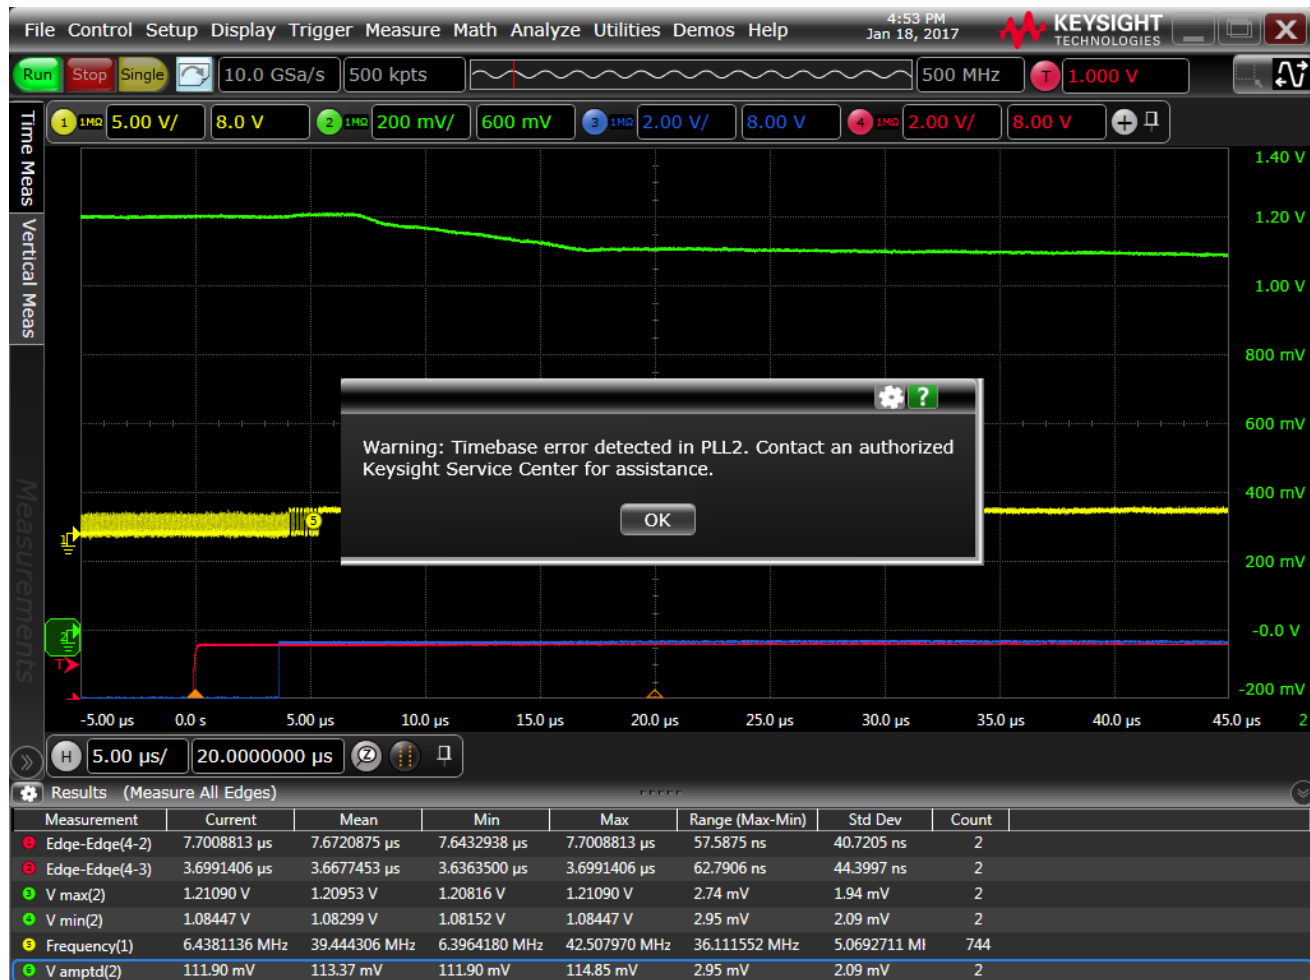
On the old acquisition board, 54911-66501/69501, a PLL2 error message sometimes occurs. The error message appears on the screen as below:

There is a new acquisition board available for the S-series scopes (54911-69511); any repairs associated with the older 54911-69501 needs to be replaced with 54911-69511.

1. Replace the acquisition board with the 54911-69511.
2. Save the Serial Numbers of the replaced and the new Acquisition Boards in Siebel. Please, follow this procedure:
