S E R V I C E N O T E

E1610A 34 Mb/s E3 Line Interface for Broadband Series**Serial Numbers:** AU00000000 / AU99999999 (All Serial Numbers)**Required modifications not completed on exchange parts.****To Be Performed By:** Agilent-Qualified Personnel**Parts Required:**

DATE: September 1997

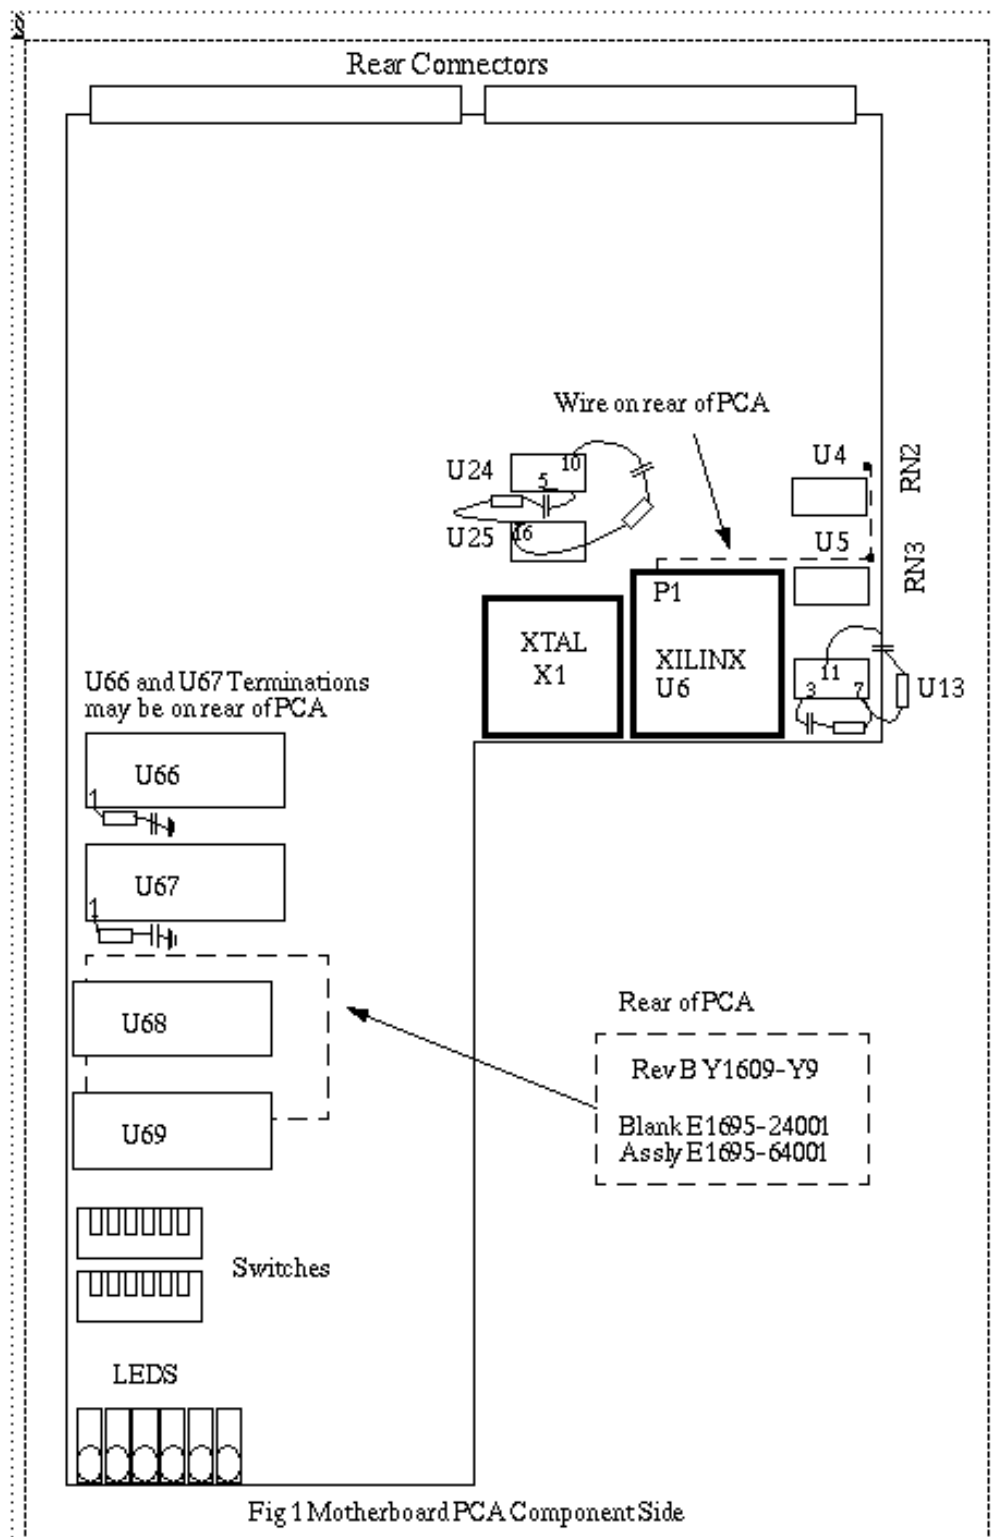
**Figure 1**

Required modifications to some E1610A exchange modules P/N E1610-69001 were not fully implemented. The effect is that spurious alarms or errors may be generated when the exchange module is installed.

If the version of the motherboard is Rev B, then the following modifications should be apparent (See Fig 1 also).

- 51R1 Resistor and 1nf Capacitor from Pin 1 of U66 to ground.
- 51R1 Resistor and 1nf Capacitor from Pin 1 of U67 to ground.
- Wire link on rear of PCA between pin P1 of U6 and Pin 9 (lifted) of U5 then to pin 9 of U4 (lifted).
- 51R1 Resistor and 1nf Capacitor in series from U13 pin 3 to U13 pin7.
- 51R1 Resistor and 1nf Capacitor in series from U13 pin 11 to U13 pin7.
- 82R5 Resistor and 1nf Capacitor in series from U24 pin 5 to U25 pin 16.
- 82R5 Resistor and 1nf Capacitor in series from U24 pin 10 to U25 pin16

Identify the Circuit board revision as shown in the diagram and determine if ALL the modifications described have been done. All parts without the required modifications completed should be marked as such ****ON THE PART**** and returned as defective.

If all of the above modifications have not been done, please return the complete, reassembled module, with an accompanying note attached to the module, identifying it as "For modification as per Service Note E1610-02".
