E1655A-01

S E R V I C E N O T E

HP E1655A HP75000 Series 90 ATM Analyzer

Disabling of ECLTRIG1 Line on E1405A or E1405B Command Module due to incorrect pin connection on E1672A or E1674A Transport Overhead Module.

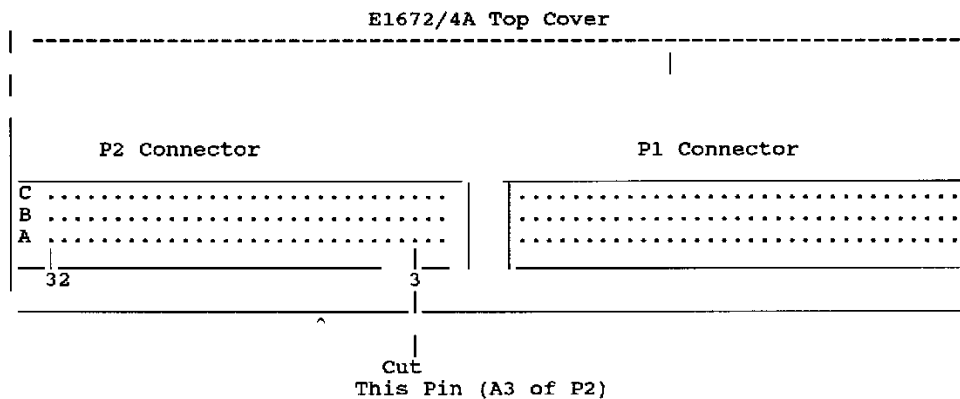
Figure 1

HP75000 Series 90 ATM Analyzers with Transport Overhead Modules with Serial numbers as shown above have a -5.2 volt supply incorrectly connected to pin A3 of the P2 connector of the E1672A and E1674A. This connects via the E1400B VXI Mainframe backplane to the ECLTRG1 output of the E1405A/B. This causes the ECLTRG1 output to be rendered inoperative. This will not in any way affect the operation of the Series 90 ATM Analyzers with E1691/2A with firmware revisions A.01.00 or A.01.01 but will affect future upgrades of the E1655A and any VXI modules which use the ECLTRG1 output and are used in the same mainframe as the Series 90.

Using the cutters recommended, clip pin A3 of the P2 connector on the E1672/4A module, off at the connector base so that it cannot make contact with the corresponding socket in the mainframe backplane. Be sure to capture the off cut of the pin to ensure that it cannot cause damage.

Refer to figure 1 below to locate the correct pin.

Cut pin A3 of P2 with due care. Be careful not to bend adjacent pins
