## S E R V I C E N O T E

**E1708A Remote Dynamic Receiver****Serial Numbers:** 3606A00101 / 3606A00300**Housing and Copper Tape May Cause Ground Loop Problems****To Be Performed By:** Agilent Qualified Personnel/Factory Only (SCD)**Parts Required:** See text.**Situation:**

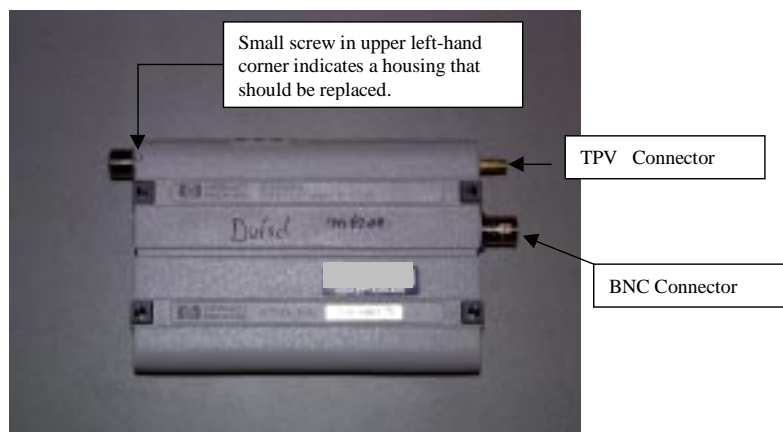
Units with serial numbers 3606A00101 to 3606A00300 were built with a housing that may or may not make a good ground contact with the BNC and TPV connectors. The resistance between these connectors should be zero ohms. However, we are finding that in some units, this resistance can vary between 0.1 and 390 ohms. This may cause a variable ground loop in our customers' machines. Furthermore, copper tape foil was used with this housing inside the Receiver. We know that ground loops and copper materials can be quality issues for our customers. Figure 1 shows how to identify an E1708A with the affected housing.

Figure 1. E1708A-C01 with housing that should be replaced.

As a result, Agilent is offering to replace these units with ones that have a new housing and no copper tape. The new housing is a tighter fit and is not subject to this ground problem. The replacement unit will be identified as E1708A-C10, which will be a refurbished E1708A with a new serial number.

Forward the affected E1708A to Santa Clara Division for refurbishment.
