## S E R V I C E N O T E

**E2411C Preprocessor Interface****Serial Numbers:** 3319A00000 / 3319A00169**Correct PLL Lock Problem****To Be Performed By:** Agilent-Qualified Personnel or Customers with adequate SMT and ESD repair facilities.**Duplicate Service Notes:** None**Parts Required:**

Clock PLL Does Not Lock at Upper Specified Frequencies

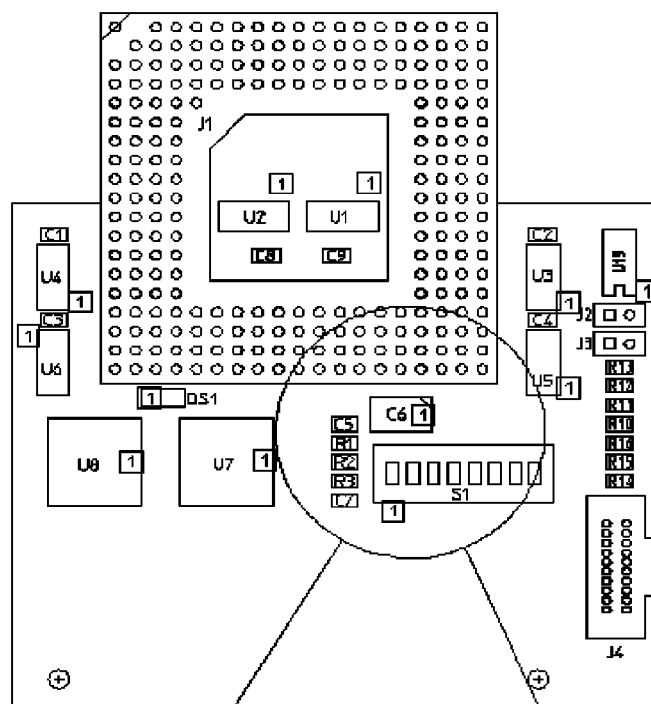
Due to an error on the silk-screened polarity marking for C6 on the preprocessor board, C6 was loaded backwards. The leakage current caused by the reversed polarity on C6, lowers the upper operating frequency of the PLL. The upper frequency cutoff is inversely proportional to the length of time the reverse voltage was applied to the capacitor.

To correct this problem, the reversed capacitor must be replaced by a new capacitor and installed with the correct polarity. Just reversing the original capacitor is not an acceptable solution because of the permanent damage to the capacitor while it was operating with reversed voltage applied.

1. Loosen the ribbon cable retainer screws.
2. Slide the clear plastic ESD cover from under the cable retainer screws.
3. Locate C6 (see figure 1)
4. Unsolder and discard this capacitor.
5. Install a new capacitor (Part Number 0180-4116) with the positive contact opposite the locator dot (see the "CORRECT" insert in figure 1).
6. Slide the loose end of the clear plastic ESD cover under the cable retainer and tighten the screws.
