# Modification Recommended Service Note

## E36155A 800W Autoranging Benchtop Power Supply, 60V, 40A

Serial Numbers: MY62101001 - MY63001001

**The Problem** – ATTENTION – Firmware update to 1.1.15-1.0.1-1.21 and newer is mandatory.

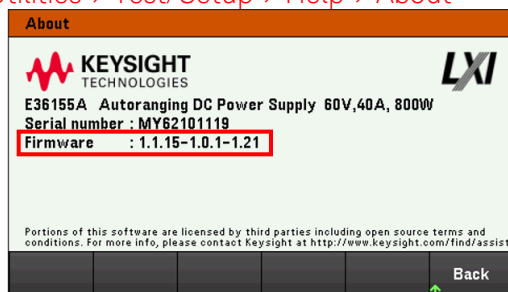
1. Check the instrument's firmware version.

At instrument front panel, go to:

Utilities > Test/Setup > Help > About

2. If the firmware version is **NOT 1.1.15-1.0.1-1.21 and newer**, please update the firmware.
3. Download the firmware file from:  
<https://keysight.com/find/E36155A> > Visit Technical Support > Driver, Firmware & Software.  
Detailed instructions for updating E36155A are available at Keysight.com.
