E4416A-16

S E R V I C E N O T E

E4416A EPM-P Single Channel Power Meter

Overload Failure in W-CDMA & HSDPA Signal Measurement when RF Input Exceeds -1dBm

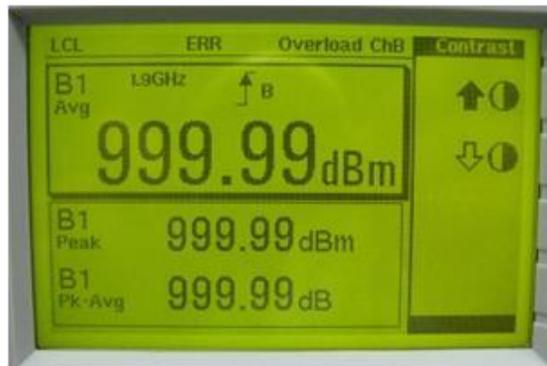
1. When the E4416A is used with the E9320-series peak and average power sensors under the 'W-CDMA' preset mode, and when the RF power source to the power sensor exceeds -1dBm, the E4416A will display an 'Overload' error as shown in the diagram below:

Figure 1: Power Meter's Display in Overload Condition

2. This problem is caused by a flip-flop amplifier component from a specific supplier that carries the part number: 1820-6473 this supplier's component is used on the E4416-60004. Only boards build with this supplier's 1820-6472 component will exhibit this issue.
3. The following test steps shows how the 'overload' error can be reproduced:
 - a) Power On the E4416A
 - b) Connect the E9320 Series peak & average power sensor to the E4416A
 - c) Perform zeroing & calibration for the power sensor
 - d) Preset the E4416A to W-CDMA mode
 - e) Connect the power sensor to a signal generator
 - f) Set the signal generator to output W-CDMA or HSDPA signal with starting RF power level at -10dBm
 - g) Turn ON "RF Output" of the signal generator
 - h) Increase the RF input power with 1dBm step
 - i) The overload failure will be noticed once the RF power level above -1dBm

1. Customer can contact Agilent’s Customer Contact Center (CCC) to return the unit to Agilent’s Service Center for rework if this symptom is observed.
2. Agilent’s Service Center will replace the affected measurement board (E4416-60004) with a new measurement board that is build with a good 1820-6472 (component locator U45) to resolve this symptom.
3. Prior to board replacement, Agilent’s Service Center will need to visually reconfirm measurement board from the customer’s unit is indeed build with the defective part. The defective part can be visually differentiated form the markings on the component, as shown below:

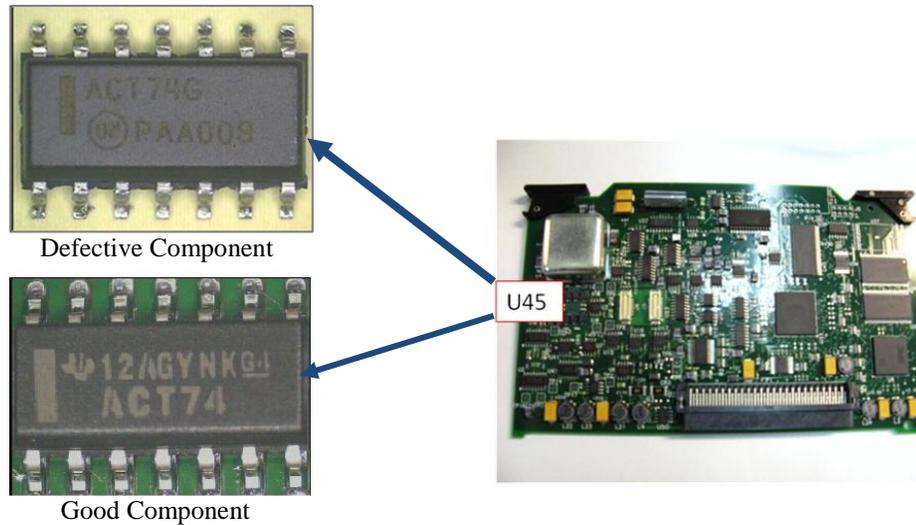
Figure 2: Defective Component Checking (1820-6472) on Measurement Board (E4416-60004)

4. After replacing the measurement board that uses the good 1820-6472 component, follow the procedured below to perform verification on the power meter:
 - a) Power ON the E4416A
 - b) Perform “Self Test” from the front panel of the E4416A to ensure all tests passed
 - c) Perform the verification test with the STE 9000 calibration software to ensure the accuracy of the E4416A. The following are the required tests in STE 9000 and it’s test duration:
