**E4418B-04A**

**S E R V I C E N O T E**

**Agilent E4418B EPM Average Power Meter**

**Remove & Refit Outer Cover To Fix EMI Gasket Issues**

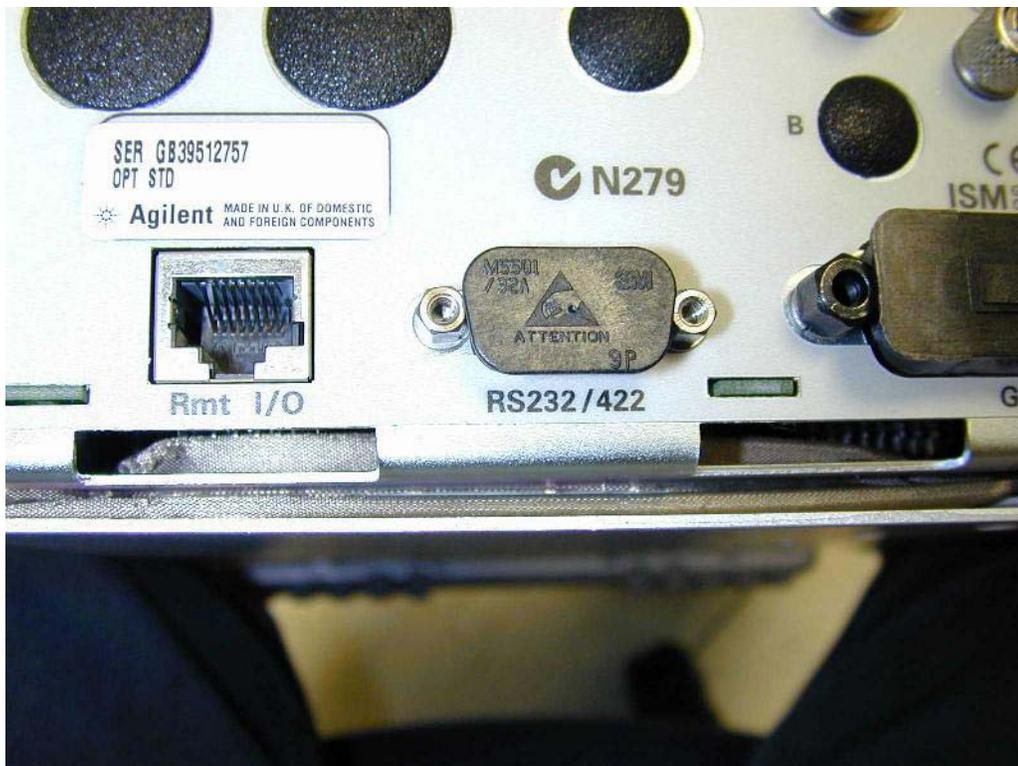
The units with serial numbers above may have a badly positioned EMI Gasket. The first indication of the problem would be via a visual inspection, where the conductive EMI Gasket may be seen to be in contact with the underside of the Comms Assembly (A4). The inspection procedure is shown in the next section. Where the gasket position is causing the unit to fail, the failure mode is uncertain, as this will depend on the area of the board it is touching. The following failure modes have been encountered so far:

Figure 1. Example of a badly positioned gasket.

1. Remove the Rear Bezel and inspect the gasket to see if it is encroaching on the Comms Assembly. See Figure 1 below for an example of a badly positioned gasket.
2. If the gasket is not positioned correctly, slide off the Outer Cover and then slide it back on again. As the gasket is part of the Outer Cover Assembly, this action will put it back into the correct position.
3. Inspect the gasket to make sure it is now positioned correctly. Verify that all the Built In Self Test tests pass.
