E4418B-07A

S E R V I C E N O T E

Agilent E4418B EPM Power Meter

Premature RAM Backup Battery Failure

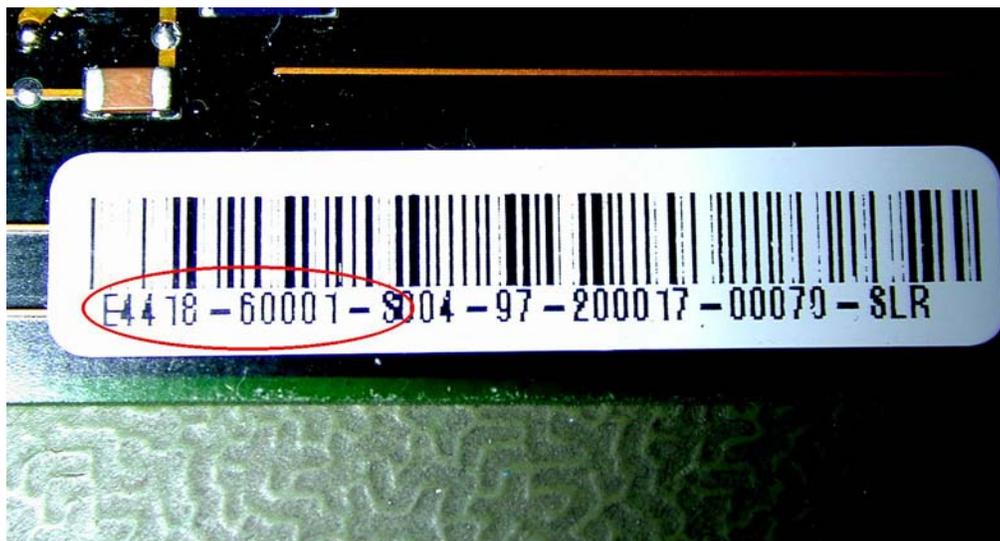
Figure 1. Label Example

1. Remove the Processor Assembly (E4418-60001) from the unit.
2. Locate the board revision data marked on the LABEL on the component side (top side) of the assembly. If the revision is identified as 'E4418-60001-S' then proceed to step 4. If the revision is NOT 'E4418-60001-S' then proceed to step 3.
