**E4418B-17A**

**S E R V I C E N O T E**

**Agilent E4418B EPM Average Power Meter**

**Front Panel Display Problems Caused by Power Assembly Cable**

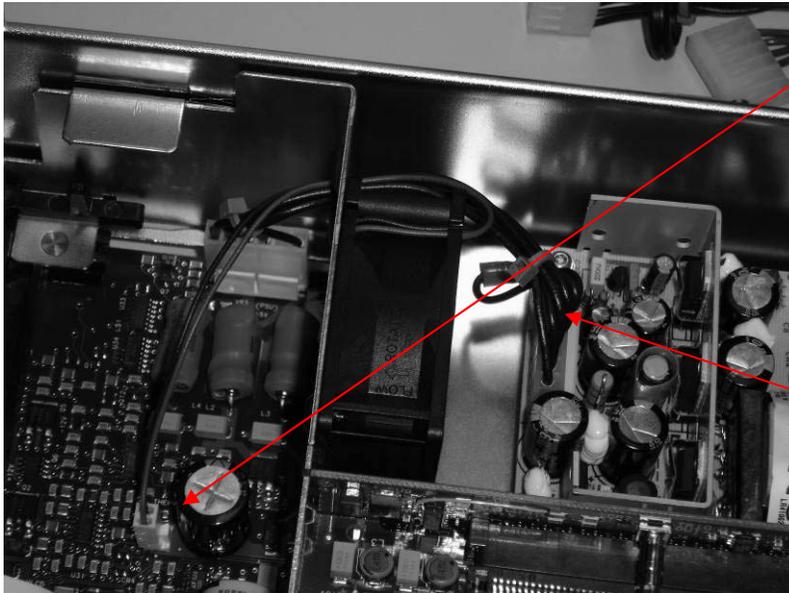
Fan connector

PSU cable New cable is RED in color

- 3) Remove fan connector and PSU cable assembly and replace with new PSU cable assembly E4418-61005. You can differentiate the cable assembly by the colors. The old cable is Black and new cable is RED.

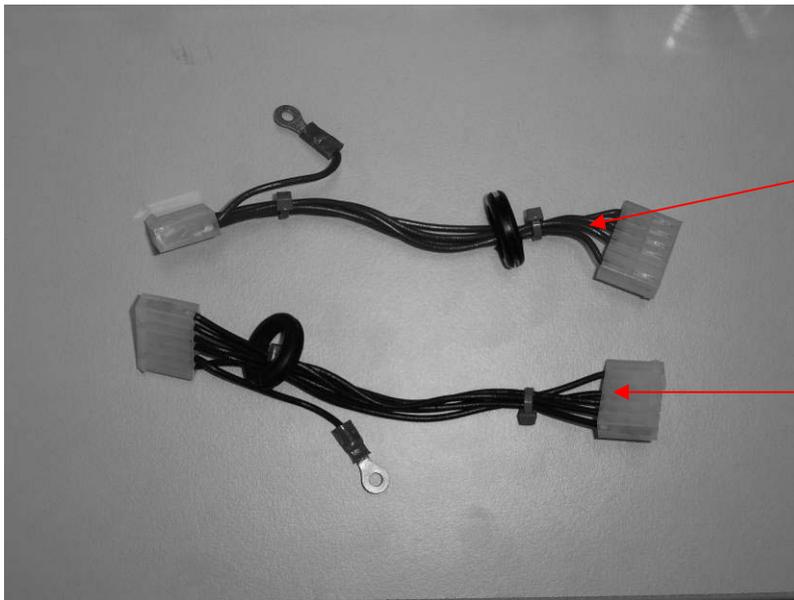
7) Photo below show different of old and new cable. The new cable is red in color whereas the old cable is black in color. The E4418-61005 has 1 ground wire.

New cable assembly

Old cable assembly

Note: If the power cable assembly is red in color, indicates that the cable already been changed. No action is needed.

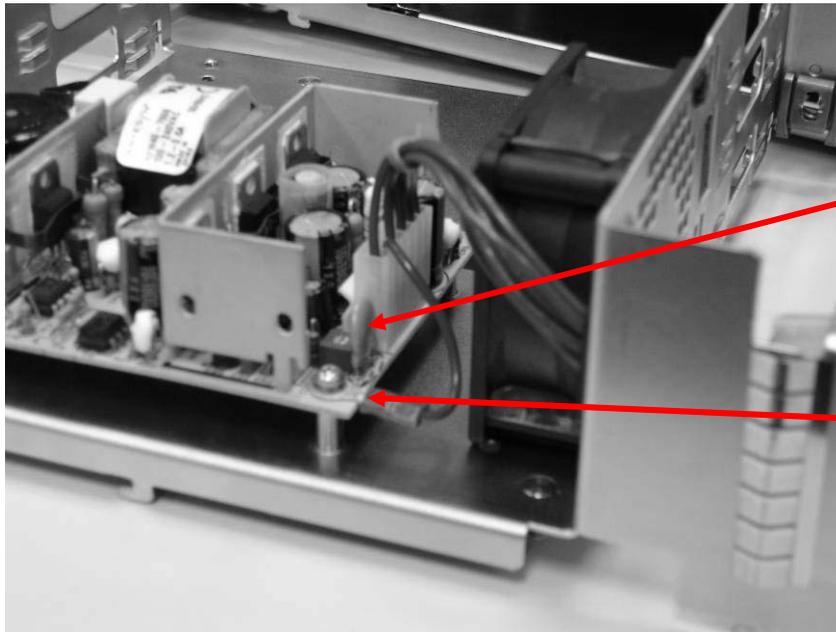
Yellow  
Capacitor.

Ground wire  
connected to  
PCB

10) This picture above shows the ground wire connection to the PCB. Please be aware that the ground connection is very close to the leg of the yellow capacitor. PLEASE DO NOT LET THE GROUND WIRE TOUCHES THE CAPASITOR'S LEG.

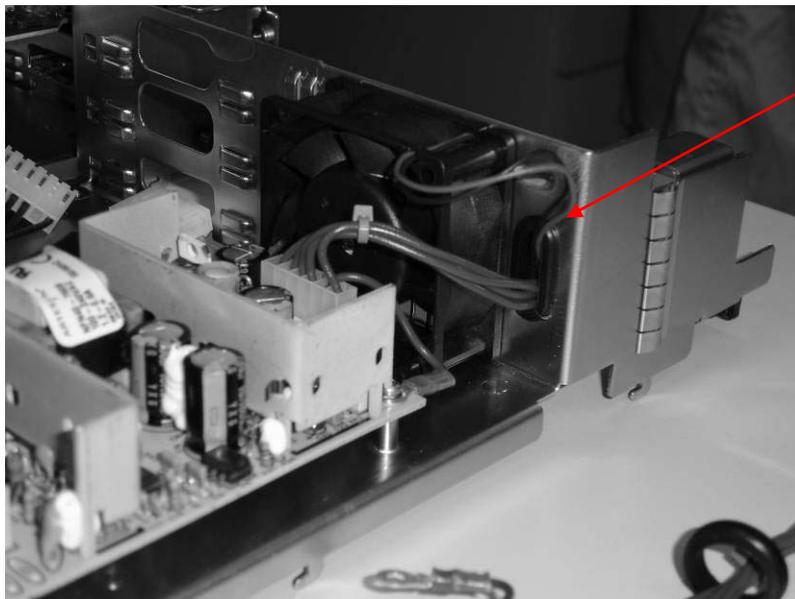
The Fan wire  
goes into the  
rubber.
