**E4419B-07A**

**S E R V I C E N O T E**

**Agilent E4419B EPM Power Meter**

**Premature RAM Backup Battery Failure**

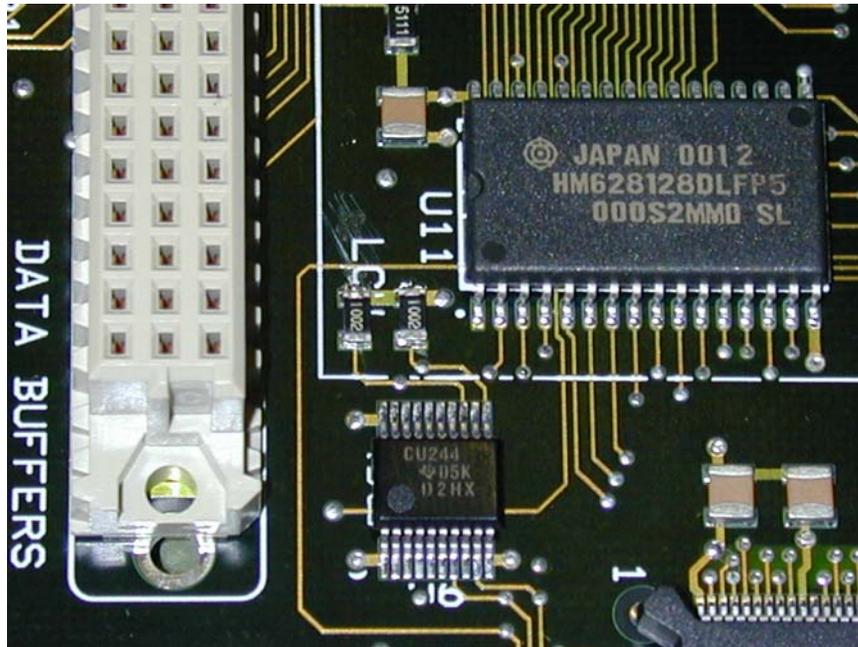
**Figure 2. Location of Surface Mount Resistors**

Two pull-up resistors were added as part of this design change. It has since been discovered that these pull-up resistors reduce the lifetime of the RAM lithium backup battery. The backup battery is needed to retain data in the memory when the unit is disconnected from the mains power supply. This will not affect measurement integrity of the unit, however the unit will lose all user data that was stored in it before the battery failure occurred. When the battery has failed it will display the following Power On Self Test error: RAM Battery Failed.

3. Processor Assembly revisions prior to 'S' are not covered by this service note. RAM backup battery failures on these boards may be detailed in a previous service note, or they may simply be caused by natural aging of the unit. Check other service notes for this unit to verify this failure mode is not likely to be caused by any other documented problems. Do not carry out steps 4 to 14.
4. Locate the two surface mount pull-up resistors (see Figure 2).
