**E4419B-18A**

# S E R V I C E N O T E

## Agilent E4419B EPM Average Power Meter

### Front Panel Display Problems Caused by Power Assembly Cable

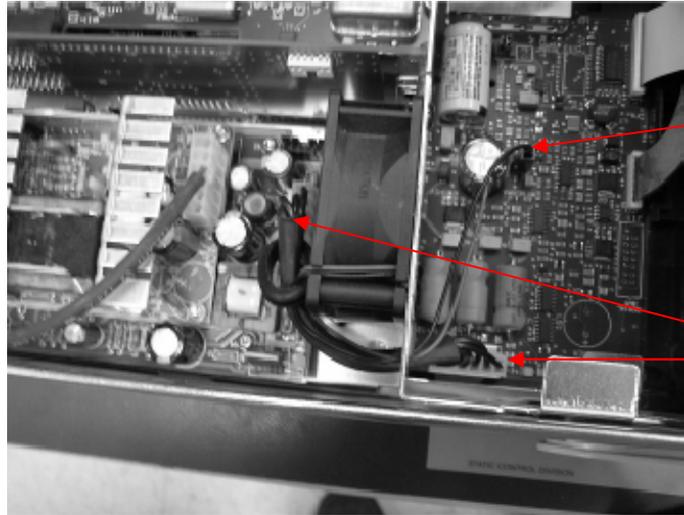
Fan connector

PSU cable assembly, E4418-61029

- 3) Remove fan connector and PSU cable assembly.

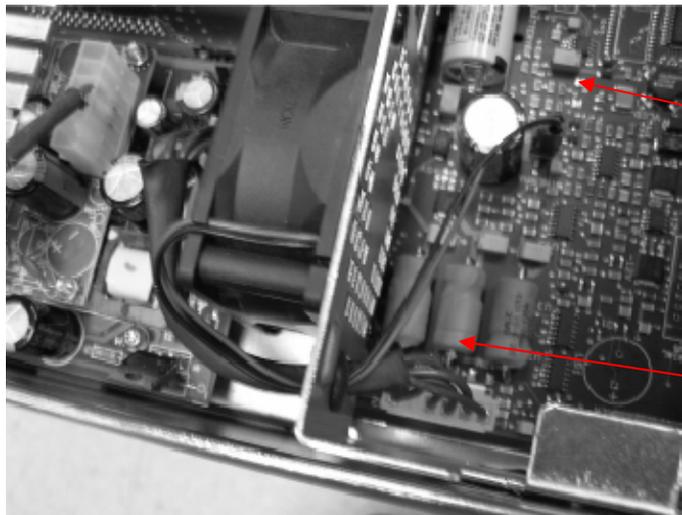
Put back fan connector

New cable with RED color

- 4) Replace with new PSU cable assembly E4418-61029. You can differentiate the cable assembly by the colors. The old cable is Black and new cable is RED.

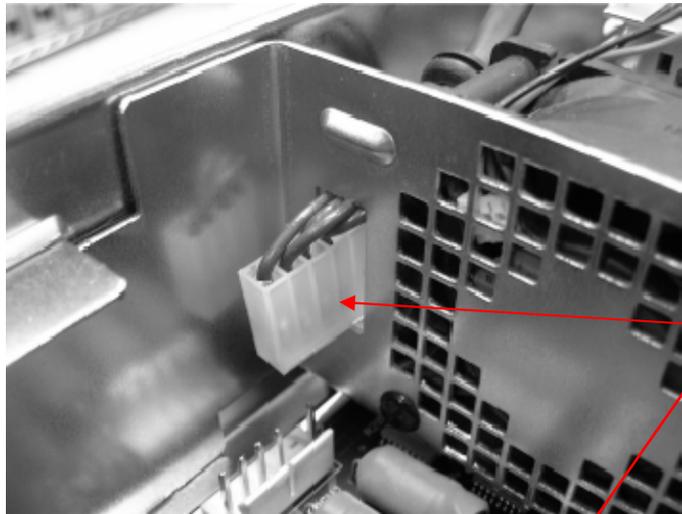
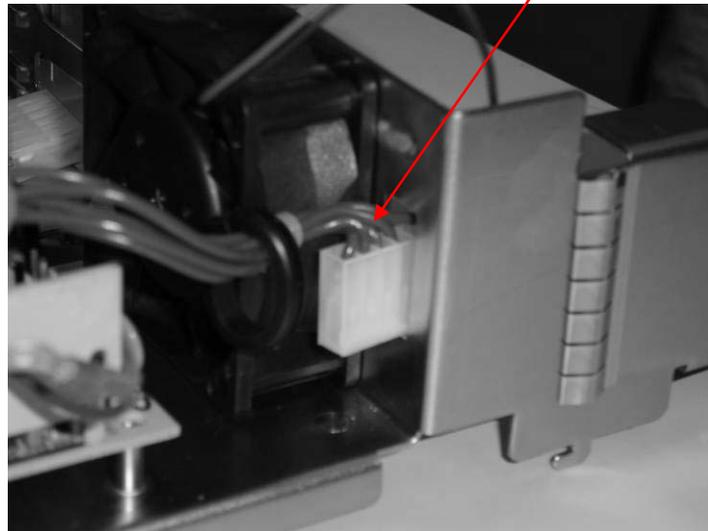
Insert the plastic casing horizontally

- 5) Here are some tips regarding the new cable. Since the plastic casing is slightly bigger in size, so you cannot directly pass through connector through hole. So you need to insert the cable horizontally. See illustration below.

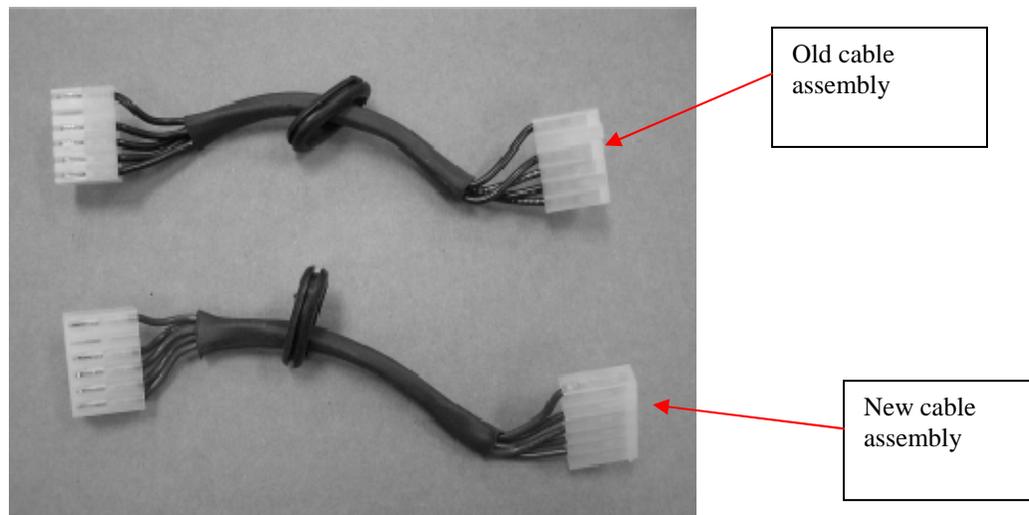
- 6) Photo below show different of old and new cable. The new cable is red in color whereas the old cable is black in color.

Note: If the power cable assembly is red in color, indicates that the cable already been changed. No action is needed.
