## S E R V I C E N O T E

**E4421A RF Signal Generator****Serial Numbers:** 0000A00000/9999Z99999

**Replacement Procedure for Q501 on Motherboard/CPU****Duplicate Service Notes:**

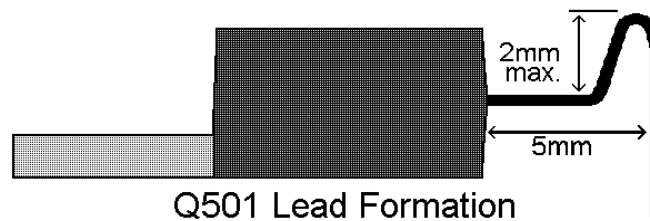
**Q501 Lead Formation**

A large proportion of motherboard failures have been caused by stress fractures internal to Q501, the series-pass transistor for the +9 volt power supply.

Obtain a new transistor and bend all three leads with needle nose pliers as shown in the drawing below. This may take some practice so it helps to order several replacement transistors. This lead formation is done to prevent future failures caused by stress fractures.

Insert the transistor into the motherboard but do NOT solder it yet. Use the shoulder washer and screw to fasten the transistor, making sure the shoulder washer is properly seated. Once the transistor is mechanically secured, it may be soldered from either the top or bottom side of the board. Using an ohmmeter, verify the transistor's tab is not shorted to ground.
