E4428C-03A

S E R V I C E N O T E

E4428C Option 506

DC blocking capacitor, from RLC supplier used in above identified serial number units may cause a power drop of approximately 20dBm

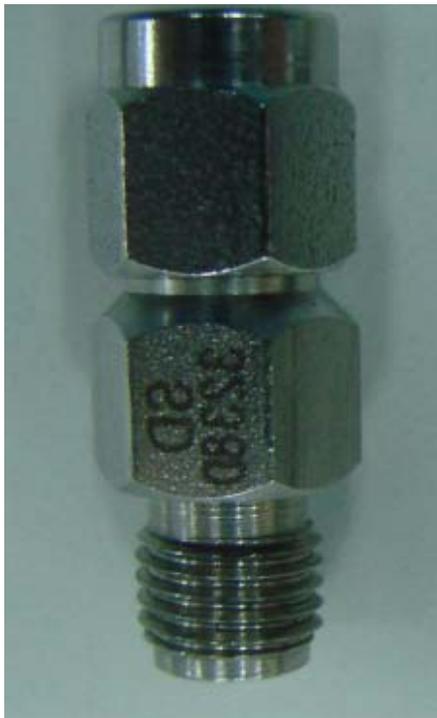
**Good part**

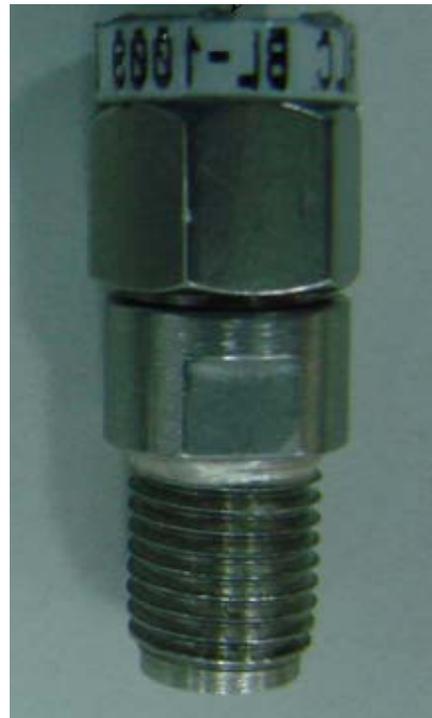
Power drop was observed on the instrument having option 506 and when operating at cold temperature (0 degree Celsius). The failure is caused by the defective DC blocking capacitor where it will show a power loss of approximately 20 dBm at low frequency setting. Repair of the assembly will be covered under warranty.

**Defective part**

1. Repair on failure after verification that the defective part is installed inside the instrument.
2. Prevent the failure by repairing the instrument in advance. When the instrument is returned for service or calibration, check the DC blocking capacitor, by looking at the physical part. The good and defective part is shown below:-

3. Location of the DC blocking capacitor and replacement procedure. Refer to the Service Guide, Section 2 Assembly Replacement, A29 DC Blocking Capacitor. Refer to post repair procedures for A29 after replacement of blocking capacitor.

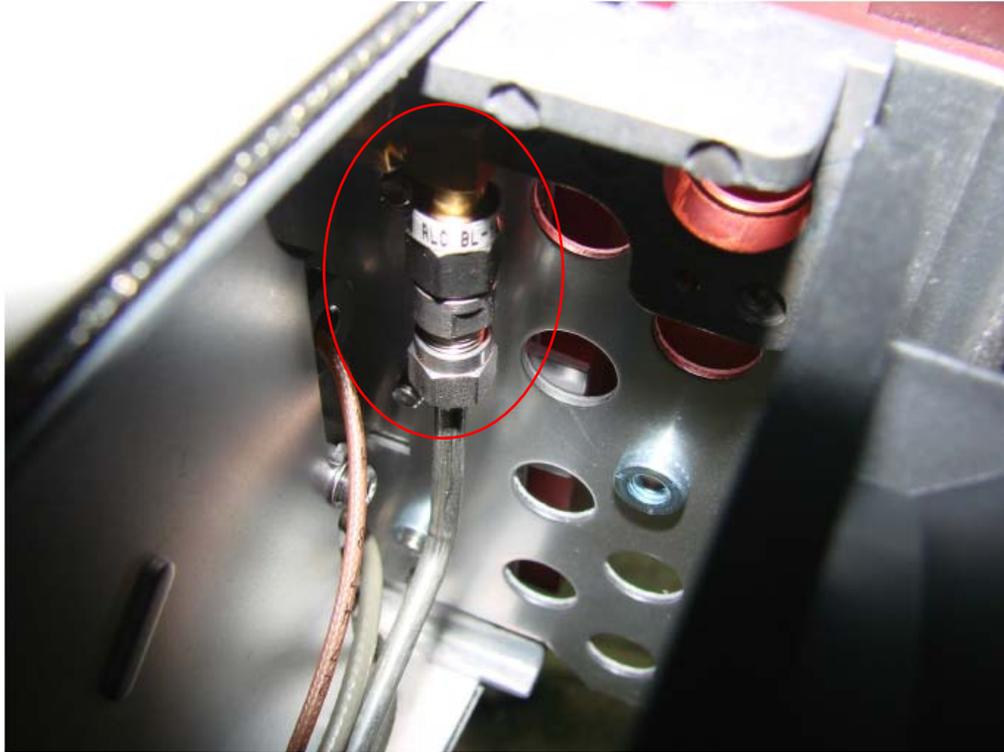
Defective part in the instrument

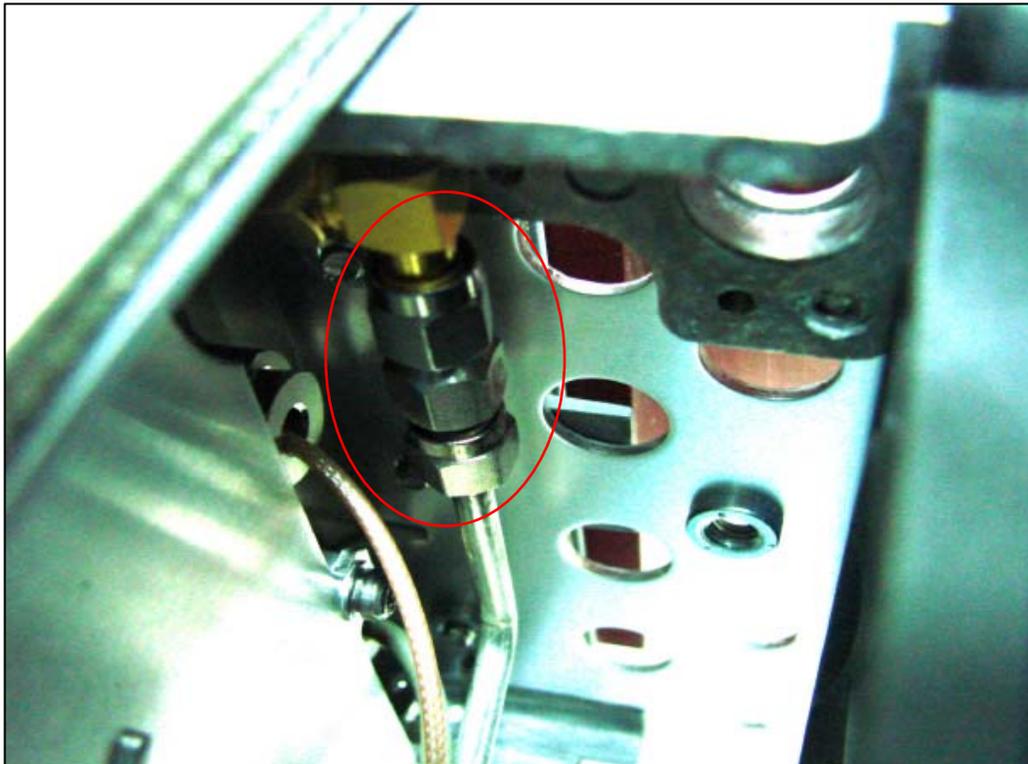
Good part in the instrument

4. Here are the actual photos taken of the DC blocking capacitor in the instrument. As long as you do not break the RF path, by removing the DC blocking capacitor from the instrument, you do not have to perform the post repair procedures of A29 for the instrument having the good DC blocking capacitor.
