**E4428C-09**

# **S E R V I C E N O T E**

## E4428C Signal Generator

**Power supply replacement for customer satisfaction purposes.**

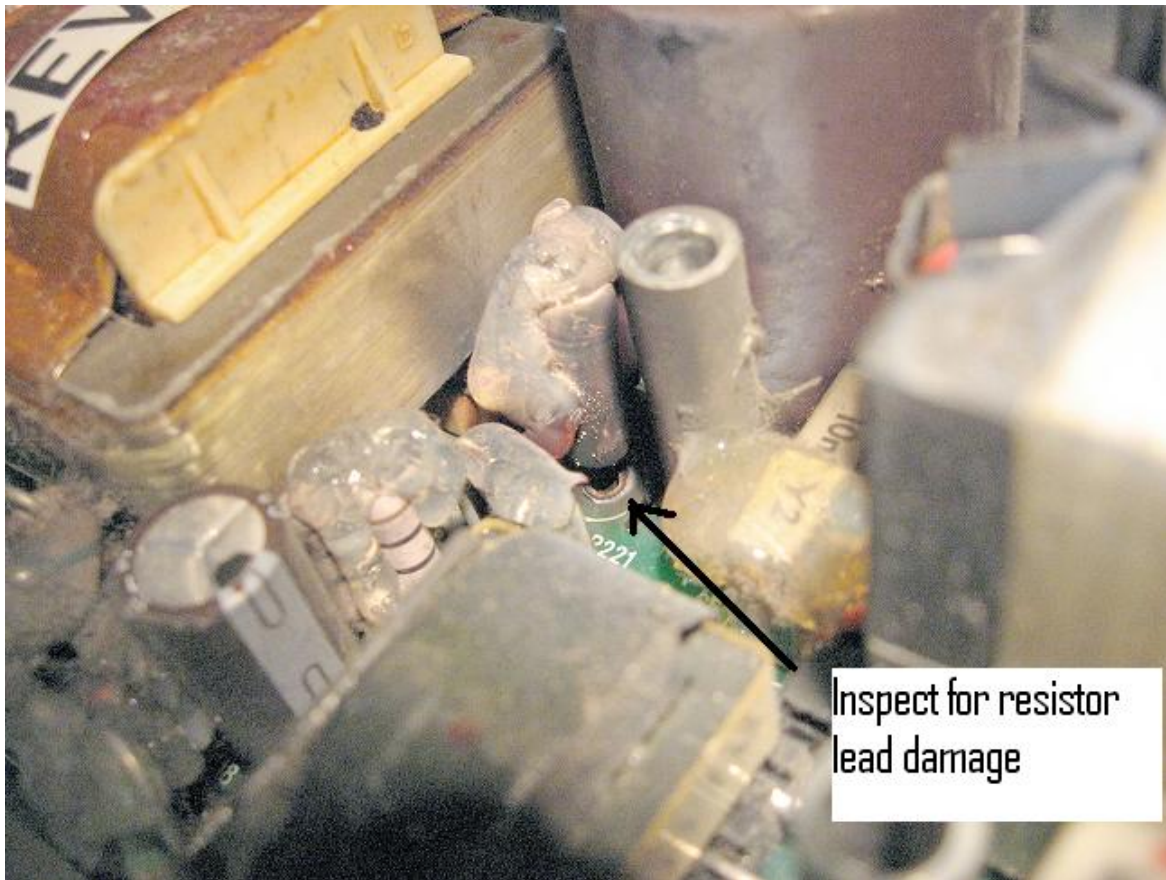
An increasing failure rate of 0950-4031 Rev B/C power supplies has been observed. For customer satisfaction failed 0950-4031 Rev B/C power supplies is authorized. 0950-4031 Rev D power supplies may be used until gone and then 0950-5037 may be used.

1. ON SPECIFIC FAILURE: Replace failed 0950-4031 Rev B/C power supplies with 0950-4031 Rev D power supplies or, 0950-5037 power supplies after stock of 0950-4031 is gone, in cases where lead failure of R6 or R9 as shown in the photograph below. Other failures are not covered by this Service Note.

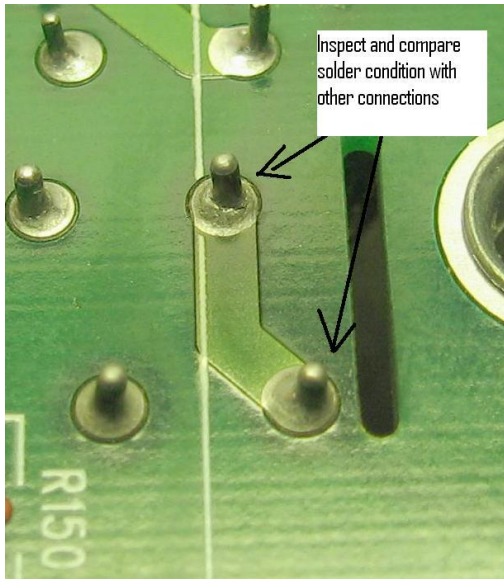
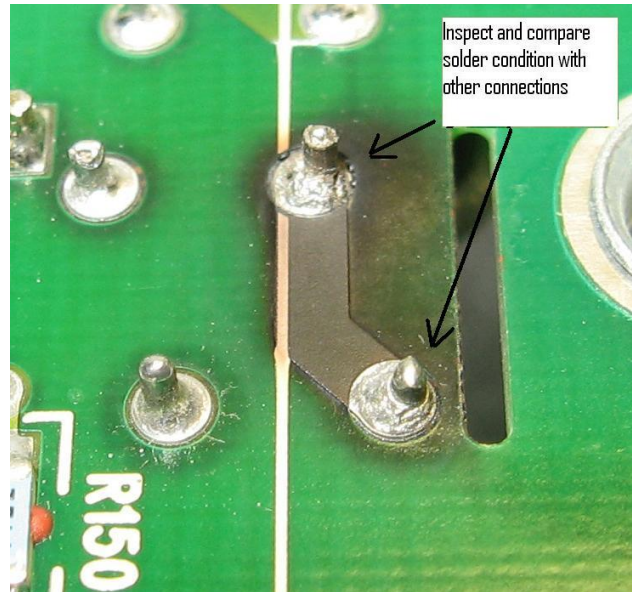
2. ON CONTACT INSPECTION: Inspect the condition of solder on the reverse side of working power supplies, in location shown in the photos below (R6/R9). If the solder is found to be deteriorated, appearing granular or partially re-melted, as shown in the picture on the right below, replace the power supply. It is normal for the solder mask to have changed color from green to grey/brown on the trace between the connections to be inspected.
3. Removed power supplies are to be disposed of locally
