E4428C-09A

Supersedes:
E4428C-09

E4428C Signal Generator

Power supply replacement for customer satisfaction purposes.

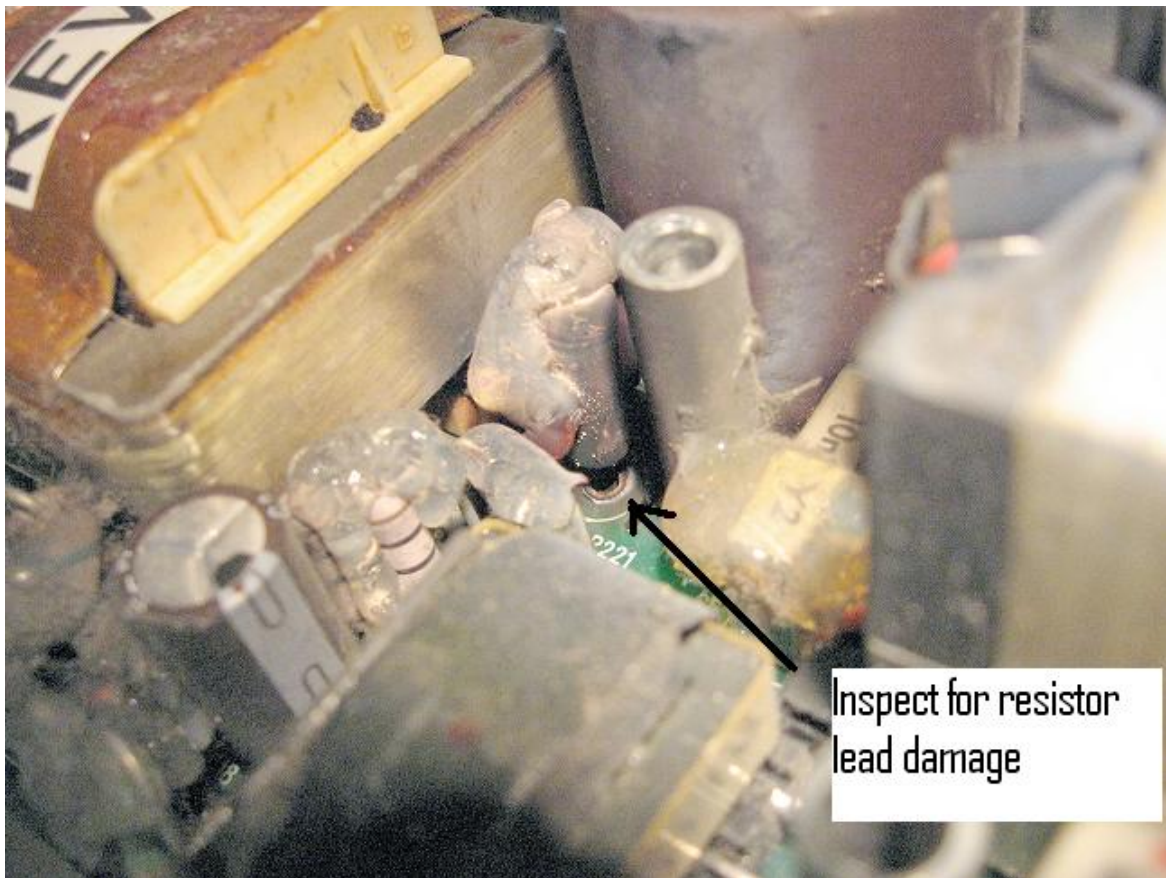
1. ON SPECIFIC FAILURE: Replace failed 0950-4031 Rev B/C power supplies with 0950-4031 Rev D power supplies or, 0950-5037 power supplies after stock of 0950-4031 is gone, in cases where lead failure of R6 or R9 as shown in the photograph below. Other failures are not covered by this Service Note.

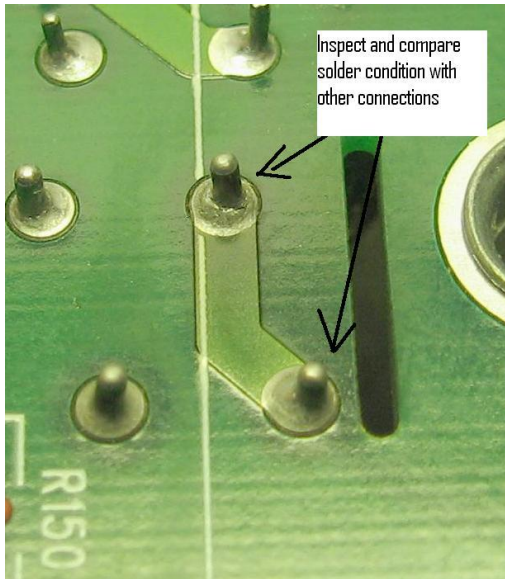
2. ON CONTACT INSPECTION: Inspect the condition of solder on the reverse side of working power supplies, in location shown in the photos below (R6/R9). If the solder is found to be deteriorated, appearing granular or partially re-melted, as shown in the picture on the right below, replace the power supply. It is normal for the solder mask to have changed color from green to grey/brown on the trace between the connections to be inspected.
3. Removed power supplies are to be disposed of locally
