E4428C-09B

**S E R V I C E N O T E**

E4428C - Signal Generator

**OLD Power supply warranted replacement on failure.**

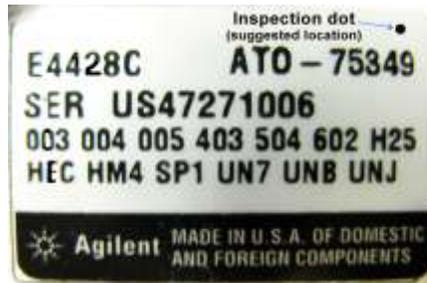
1. For a suspected E4428C power supply failure, check the rear panel serial tag for a small black inspection dot (see image below). If a black dot is present, similar to what is depicted in the upper right corner, the instrument power supply has been previously replaced and no further action is required related to this Service Note.

- 5. Using a permanent marker, place a black dot on the serial tag as depicted in step 1.
- 6. Reference this Service Note E4428C-09B in all documentation or correspondence.
- 7. Make a copy and fill out the Instrument Tracking Data Form below. Include this filled out form with the failed Power Supply and **RETURN** both to the factory (Shipping Address below) for tracking and analysis.

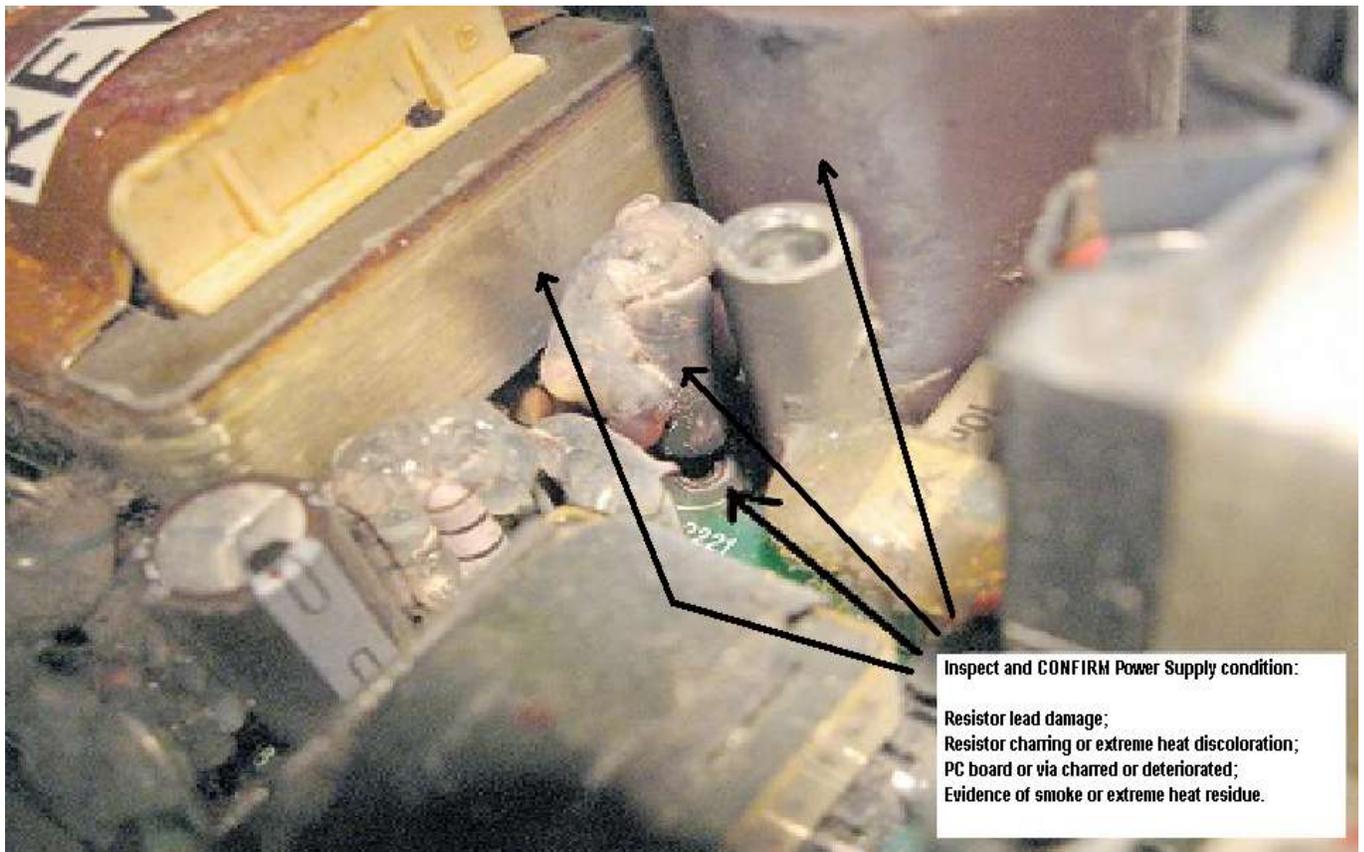
Older E4428C may experience a power supply failure of the original installed **0950-4031 Rev B/C** power supplies. Not a safety issue, the failures can occur due to the power supply PC board eventually deteriorating after being subjected to a prolonged exposure to the high temperature components associated with the power factor correction resistors.

2. If the dot is missing proceed to step 3.
3. **FOR THIS SPECIFIC FAILURE** where the power supply failed due to lead failure of R6 or R9 and/or PC board has deteriorated, as depicted in the photograph below, replace failed power supply P/N: 0950-4031 Rev B/C with current power supply P/N: 0950-5037.

- 4. The associated PC board deterioration and failure location should clearly indicate from the evidence that the PC board or resistors arced or smoked at time of failure. Charring, discoloration and/or smoke residue should be present. The resistor and transformer above are strong indications that a catastrophic failure occurred.
