**E4430B-11****S E R V I C E N O T E**Supersedes:  
NONE**ESG “B” Signal Generator E4430B**

**Defective Waveform Sequence SRAM on the Dual Arbitrary, UND board (A5) and iDEN Dual Arbitrary, Special Option H60 board causes waveform become distorted when playback.****To Be Performed By: Agilent-Qualified Personnel****Parts Required:**

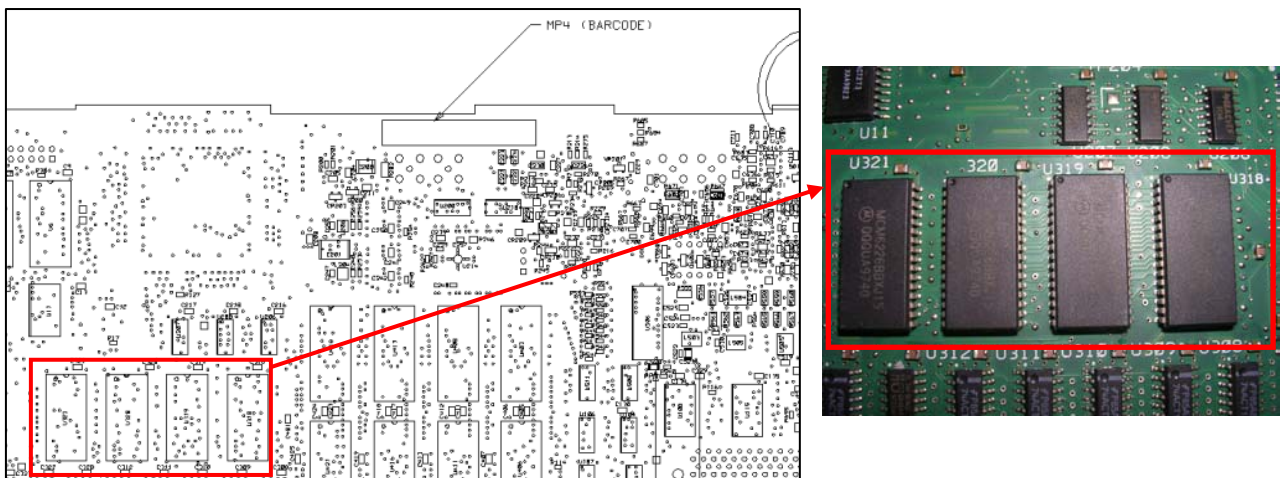
The ESG-B D/DP Family of Signal Generators has been experiencing failures in the UND (E4400-60187) and Option H60 (E4400-60186) board assemblies. This is due to a failure of the waveform sequence SRAM ICs. There are total 4 affected waveform sequence SRAM ICs on the UND and Option H60 assembly, designator U318, U319, U320, U321. The failure will cause the waveform playback become distorted. This may happen immediately after Arbitrary Function is turned on, or after it has been play-backed for a short period of time. This potentially happened when large waveform files are being playback. All ESG-B D/DP units with the symptoms mentioned above required the waveform sequence memory chips to be replaced. The kit, E4400-60753 contains 4 pieces of the SRAM ICs.

1. Repair on failure.
2. Prevent future occurrences due to a defective waveform sequence memory chips (U318, U319, U320, U321) by replacing the 4 affected chips.
3. Locate the U318, U319, U320 and U321 which are located at the bottom side of the UND or H60 board.

4. Replaced the affected components. **Caution:** Please use the appropriate soldering tools and you must be certified to perform the soldering to prevent any quality or reliability issue due to soldering workmanship.
5. Once the affected components had been replaced, perform:-
  - i) Dual Arb Waveform Generator Check. This test can be performed by using the TME software or the ESG-B Classics Software, and
  - ii) If customer waveform is stored in the NVARB RAM, playback the waveform and observed on the oscilloscope for any waveform distortion.
