**E4433B-11****S E R V I C E N O T E**Supersedes:  
NONE**ESG “B” Signal Generator E4433B**

**Defective Waveform Sequence SRAM on the Dual Arbitrary, UND board (A5) and iDEN Dual Arbitrary, Special Option H60 board causes waveform become distorted when playback.****To Be Performed By: Agilent-Qualified Personnel****Parts Required:**

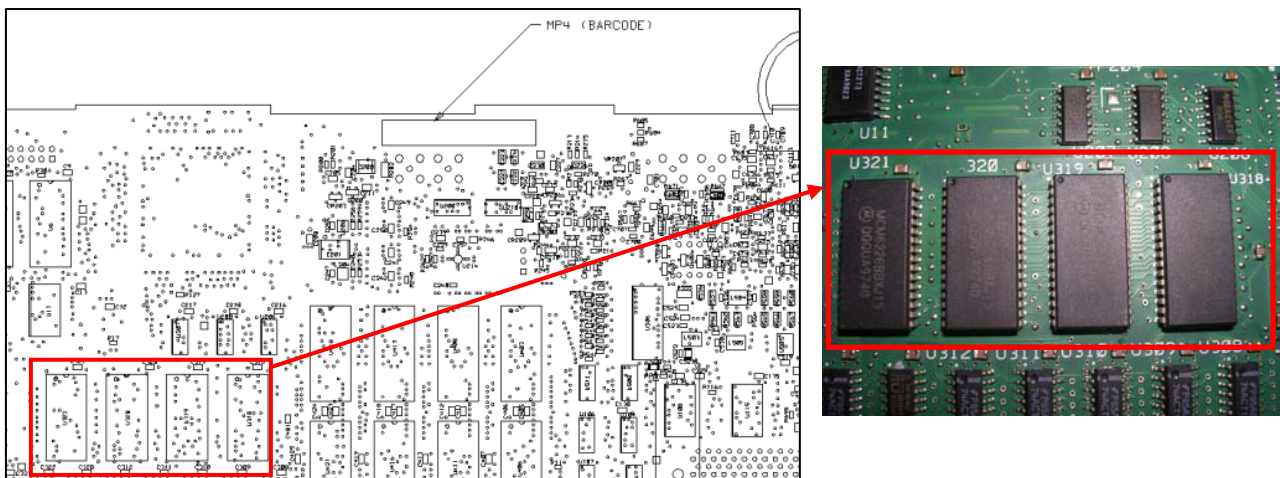
1. Repair on failure.
2. Prevent future occurrences due to a defective waveform sequence memory chips (U318, U319, U320, U321) by replacing the 4 affected chips.
3. Locate the U318, U319, U320 and U321 which are located at the bottom side of the UND or H60 board.

4. Replaced the affected components. **Caution:** Please use the appropriate soldering tools and you must be certified to perform the soldering to prevent any quality or reliability issue due to soldering workmanship.
5. Once the affected components had been replaced, perform:-
  - i) Dual Arb Waveform Generator Check. This test can be performed by using the TME software or the ESG-B Classics Software, and
  - ii) If customer waveform is stored in the NVARB RAM, playback the waveform and observed on the oscilloscope for any waveform distortion.
