**E4434B-11**

**S E R V I C E N O T E**

**ESG “B” Signal Generator E4434B**

**Defective Waveform Sequence SRAM on the Dual Arbitrary, UND board (A5) and iDEN Dual Arbitrary, Special Option H60 board causes waveform become distorted when playback.**

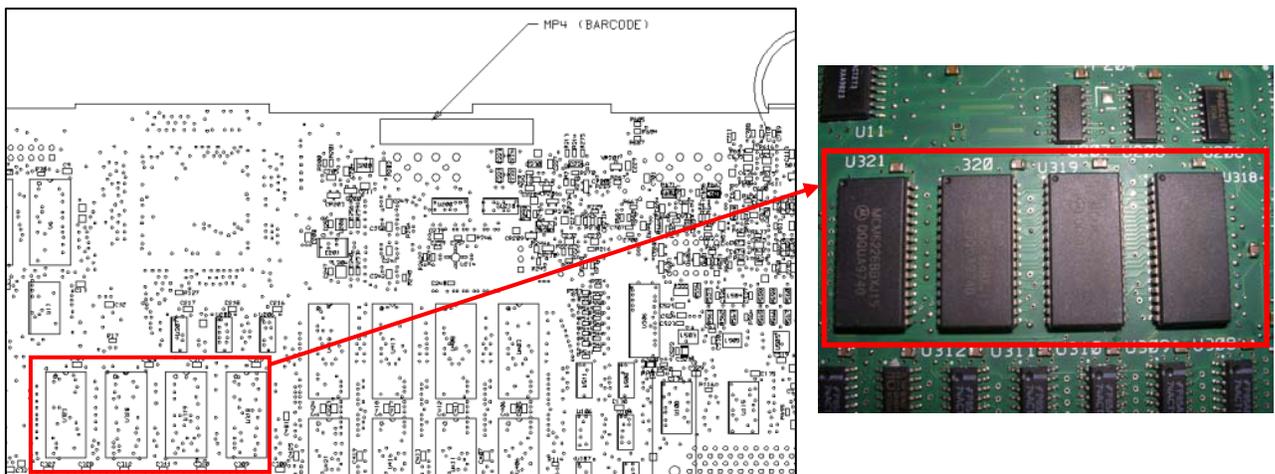
The ESG-B D/DP Family of Signal Generators has been experiencing failures in the UND (E4400-60187) and Option H60 (E4400-60186) board assemblies. This is due to a failure of the waveform sequence SRAM ICs. There are total 4 affected waveform sequence SRAM ICs on the UND and Option H60 assembly, designator U318, U319, U320, U321. The failure will cause the waveform playback become distorted. This may happen immediately after Arbitrary Function is turned on, or after it has been play-backed for a short period of time. This potentially happened when large waveform files are being playback. All ESG-B D/DP units with the symptoms mentioned above required the waveform sequence memory chips to be replaced. The kit, E4400-60753 contains 4 pieces of the SRAM ICs.

1. Repair on failure.
2. Prevent future occurrences due to a defective waveform sequence memory chips (U318, U319, U320, U321) by replacing the 4 affected chips.
3. Locate the U318, U319, U320 and U321 which are located at the bottom side of the UND or H60 board.

4. Replaced the affected components. **Caution:** Please use the appropriate soldering tools and you must be certified to perform the soldering to prevent any quality or reliability issue due to soldering workmanship.
5. Once the affected components had been replaced, perform:-
  - i) Dual Arb Waveform Generator Check. This test can be performed by using the TME software or the ESG-B Classics Software, and
  - ii) If customer waveform is stored in the NVARB RAM, playback the waveform and observed on the oscilloscope for any waveform distortion.
