**E4438C-09**

# S E R V I C E N O T E

## E4438C ESG Vector Signal Generator

**Error –310 “BBG1 SH4 ready line busy”** Error Message may appear on in the E4438C error que while the unit is booting up. This error may be eliminated by the following modification to the BBG1 board (E4400-60744)

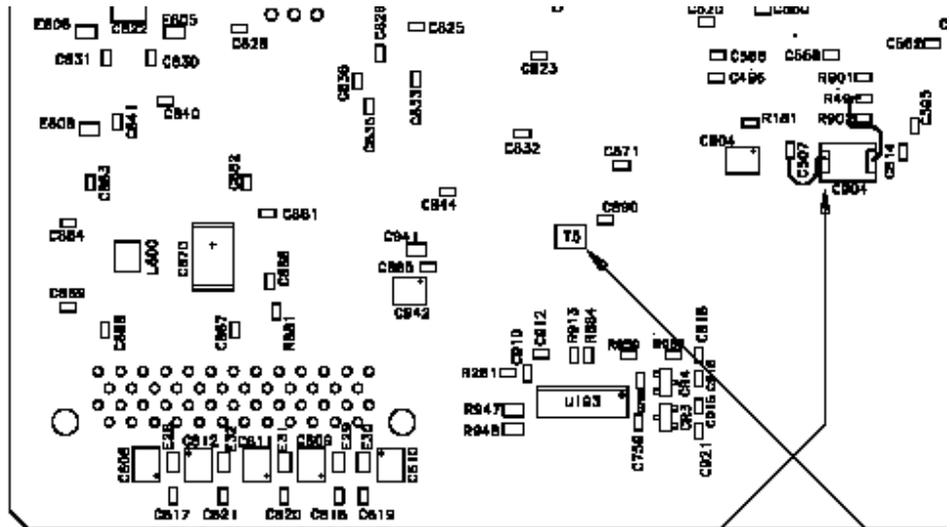
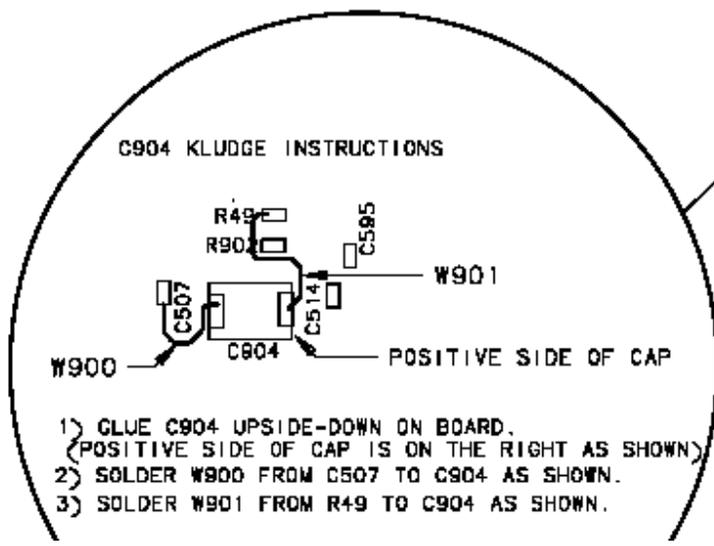
During the boot up of the E4438C, the following Error Message may appear in the error que. **Error -310 "BBG1 SH4 ready line busy"**

This error may be eliminated by the addition of a capacitor and two wire. Installing this modification to the BBG1 board (E4400-60744) might correct this problem.

Perform the follow modification to the E4400-60744 board bottom side.
