E4438C-18A

S E R V I C E N O T E

E4438C Option 506

DC blocking capacitor, from RLC supplier used in above identified serial number units may cause a power drop of approximately 20dBm

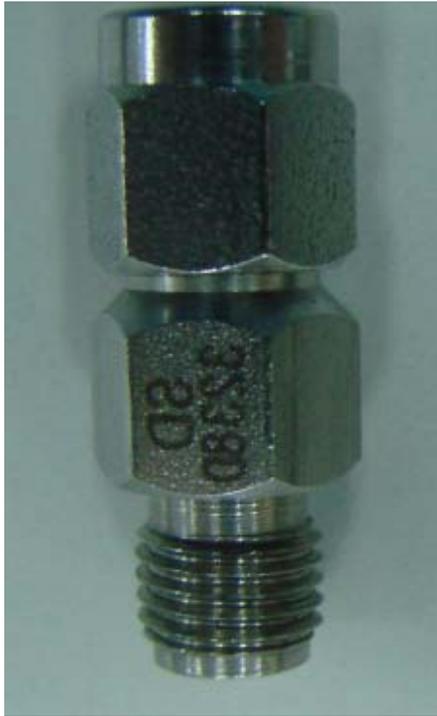
**Good part**

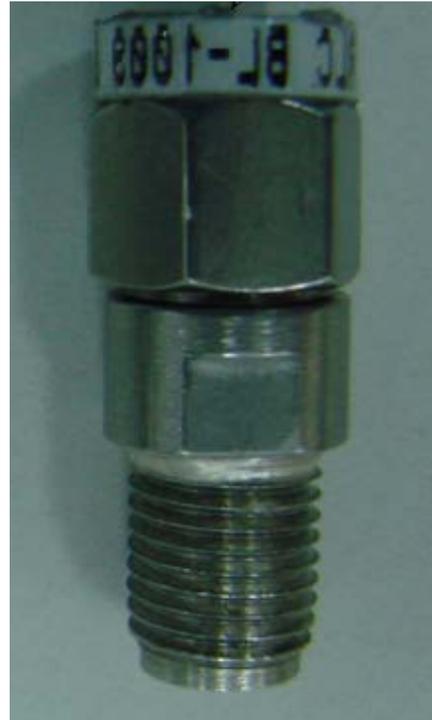
Power drop was observed on the instrument having option 506 and when operating at cold temperature (0 degree Celsius). The failure is caused by the defective DC blocking capacitor where it will show a power loss of approximately 20 dBm at low frequency setting. Repair of the assembly will be covered under warranty.

**Defective part**

1. Repair on failure after verification that the defective part is installed inside the instrument.
2. Prevent the failure by repairing the instrument in advance. When the instrument is returned for service or calibration, check the DC blocking capacitor, by looking at the physical part. The good and defective part is shown below:-

3. Location of the DC blocking capacitor and replacement procedure. Refer to the Service Guide, Section 2 Assembly Replacement, A29 DC Blocking Capacitor. Refer to post repair procedures for A29 after replacement of blocking capacitor.

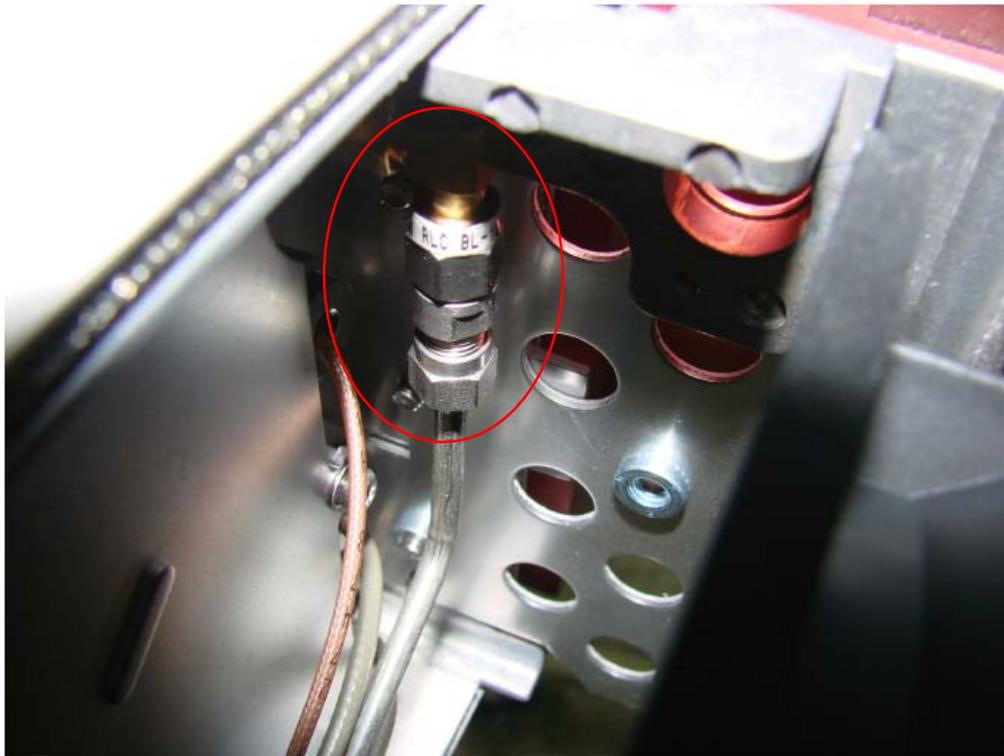
Defective part in the instrument

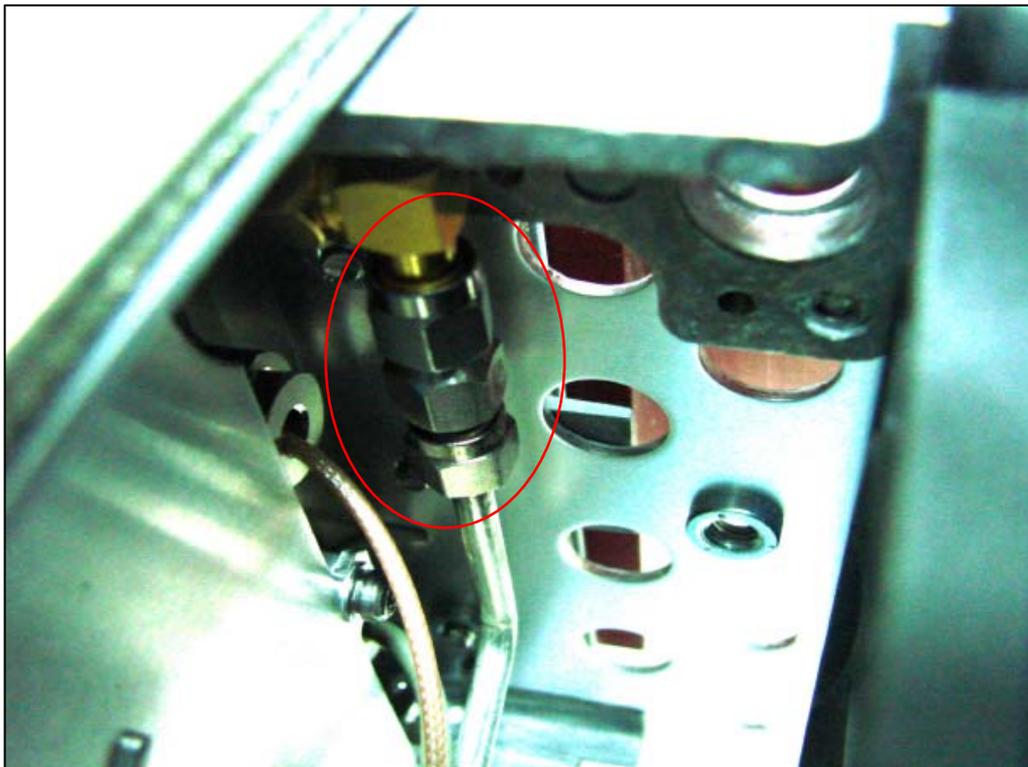
4. Here are the actual photos taken of the DC blocking capacitor in the instrument. As long as you do not break the RF path, by removing the DC blocking capacitor from the instrument, you do not have to perform the post repair procedures of A29 for the instrument having the good DC blocking capacitor.

Good part in the instrument
