**E4438C-20A**

# **S E R V I C E                      N O T E**

## **E4438C Vector Signal Generator**

**Power supply replacement for customer satisfaction purposes.**

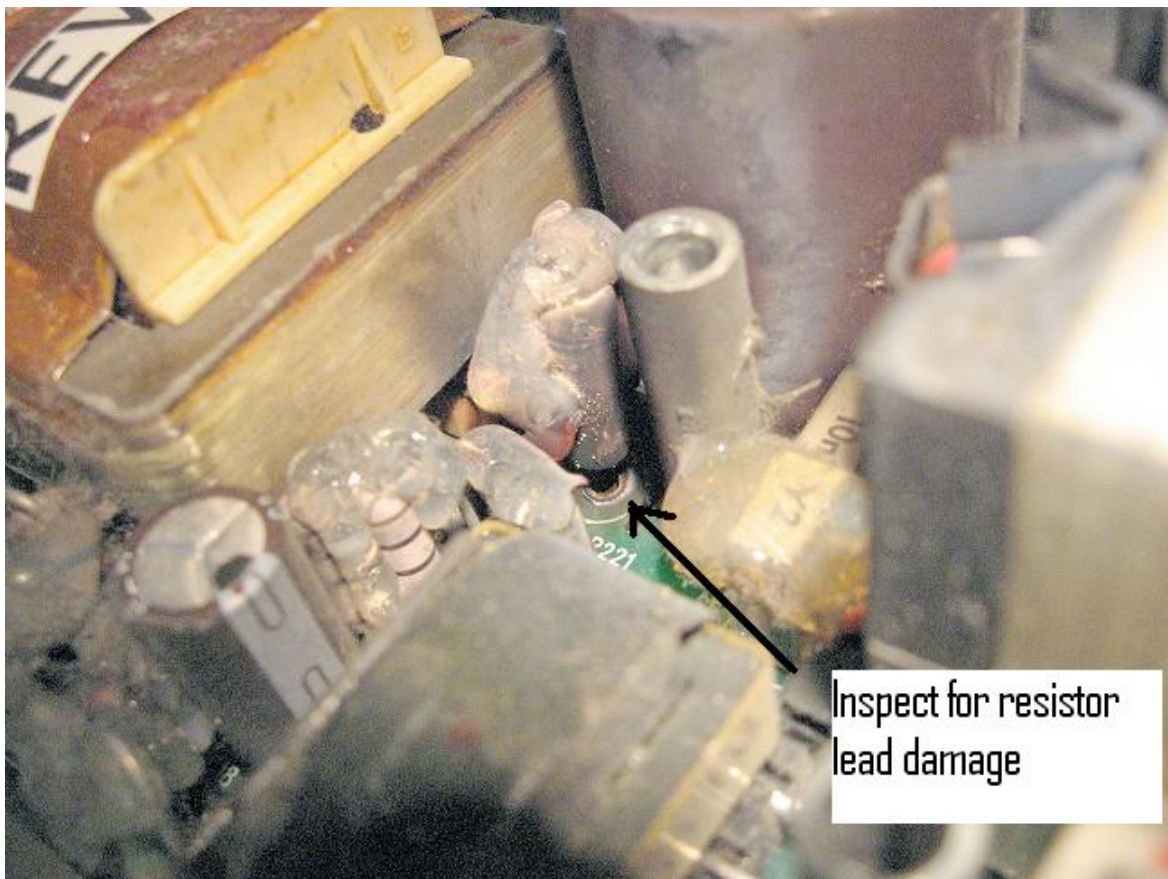
An increasing failure rate of 0950-4031 Rev B/C power supplies has been observed. For customer satisfaction, on contact (at time of calibration or other repair) inspection and replacement of 0950-4031 Rev B/C power supplies is authorized as shown below. 0950-4031 Rev D power supplies may be used until gone and then 0950-5037 may be used.

1. ON SPECIFIC FAILURE: Replace failed 0950-4031 Rev B/C power supplies with 0950-4031 Rev D power supplies or, 0950-5037 power supplies after stock of 0950-4031 is gone, in cases where lead failure of R6 or R9 as shown in the photograph below. Other failures are not covered by this Service Note.

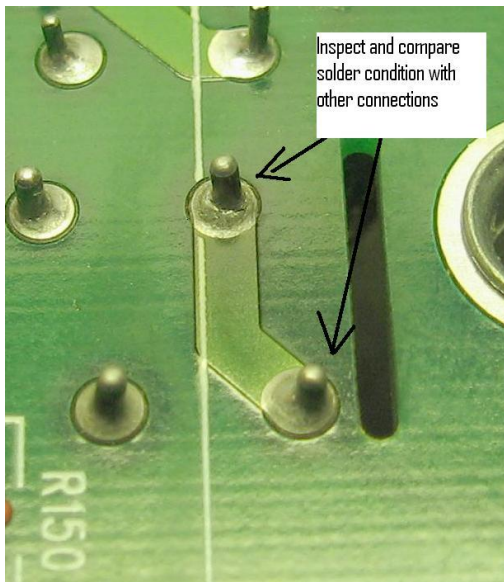
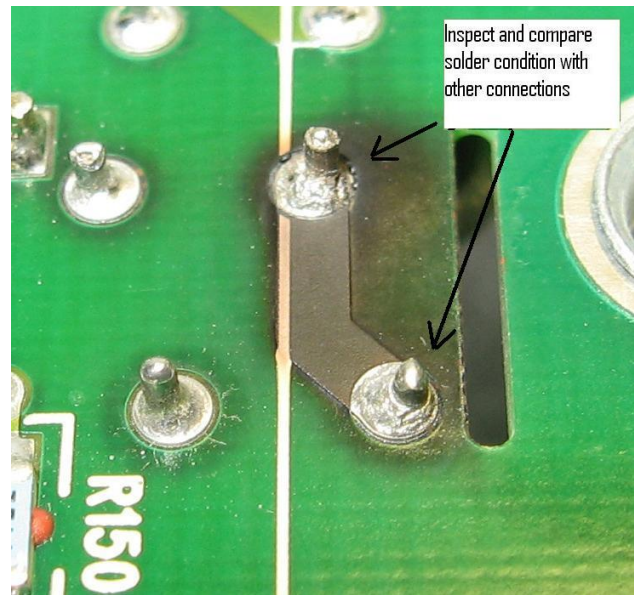
2. ON CONTACT INSPECTION: Inspect the condition of solder on the reverse side of working power supplies, in location shown in the photos below (R6/R9). If the solder is found to be deteriorated, appearing granular or partially re-melted, as shown in the pictures on the right below, replace the power supply. It is normal for the solder mask to have changed color from green to grey/brown on the trace between the connections to be inspected.
3. Removed power supplies are to be disposed of locally
