**E4438C-20B**

**S E R V I C E**

**N O T E**

## E4438C - Vector Signal Generator

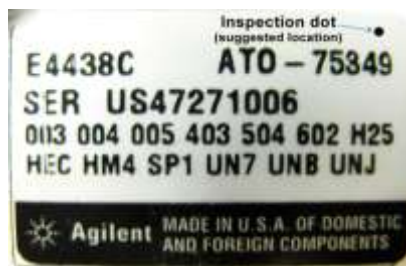
1. For a suspected E4438C power supply failure, check the rear panel serial tag for a small black inspection dot (see image below). If a black dot is present, similar to what is depicted in the upper right corner, the instrument power supply has been previously replaced and no further action is required related to this Service Note.

5. Using a permanent marker, place a black dot on the serial tag as depicted in step 1.
6. Reference this Service Note E4438C-20B in all documentation or correspondence.
7. Make a copy and fill out the Instrument Tracking Data Form below. Include this filled out form with the failed Power Supply and **RETURN** both to the factory (Shipping Address below) for tracking and analysis.

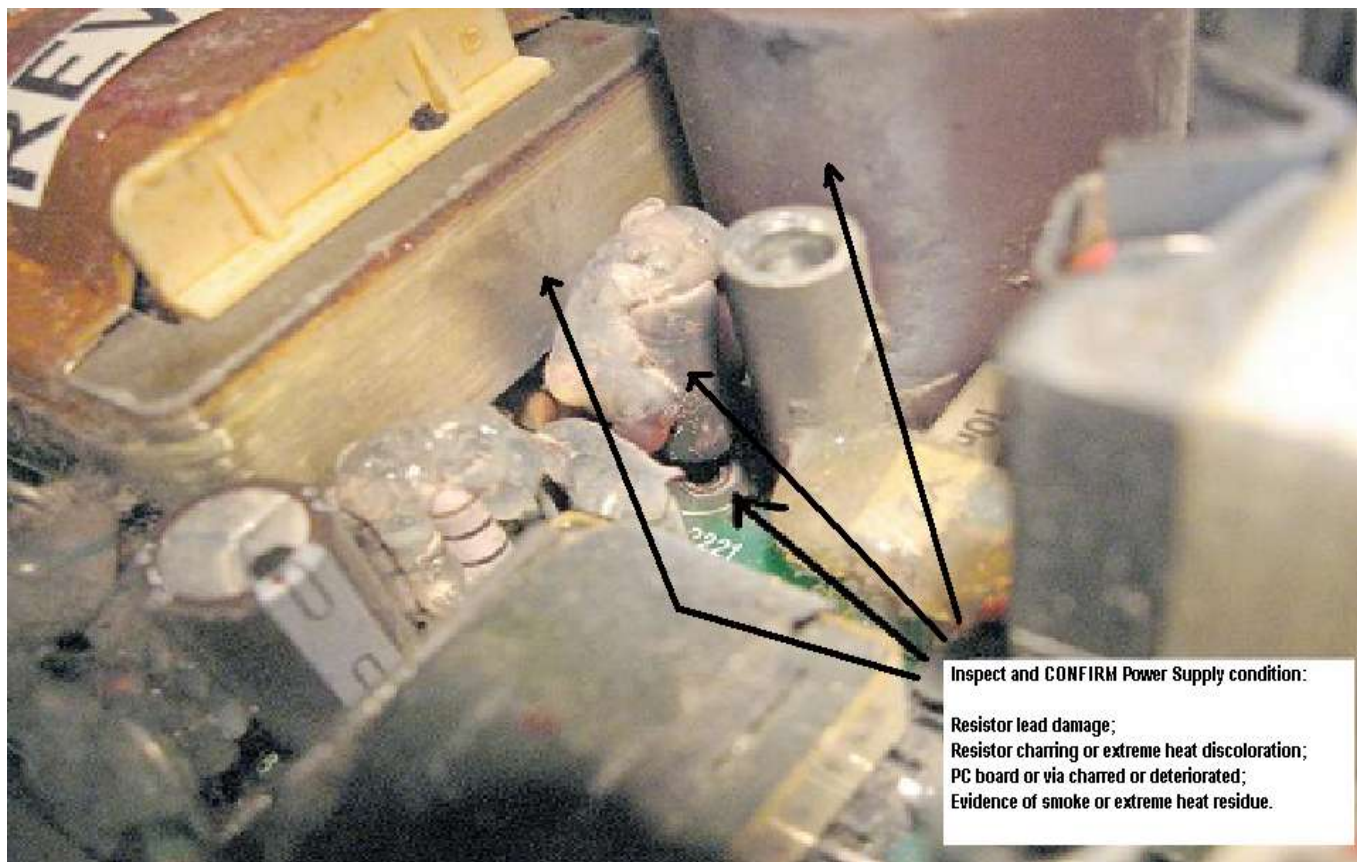
Older E4438C may experience a power supply failure of the original installed **0950-4031 Rev B/C** power supplies. Not a safety issue, the failures can occur due to the power supply PC board eventually deteriorating after being subjected to a prolonged exposure to the high temperature components associated with the power factor correction resistors.

2. If the dot is missing proceed to step 3.
3. **FOR THIS SPECIFIC FAILURE** where the power supply failed due to lead failure of R6 or R9 and/or PC board has deteriorated, as depicted in the photograph below, replace failed power supply P/N: 0950-4031 Rev B/C with current power supply P/N: 0950-5037.

4. The associated PC board deterioration and failure location should clearly indicate from the evidence that the PC board or resistors arced or smoked at time of failure. Charring, discoloration and/or smoke residue should be present. The resistor and transformer above are strong indications that a catastrophic failure occurred.
