E4980A-01

S E R V I C E N O T E

E4980A Precision LCR Meter 20 Hz to 2 MHz

Power supply for E4980A might be defective due to its design

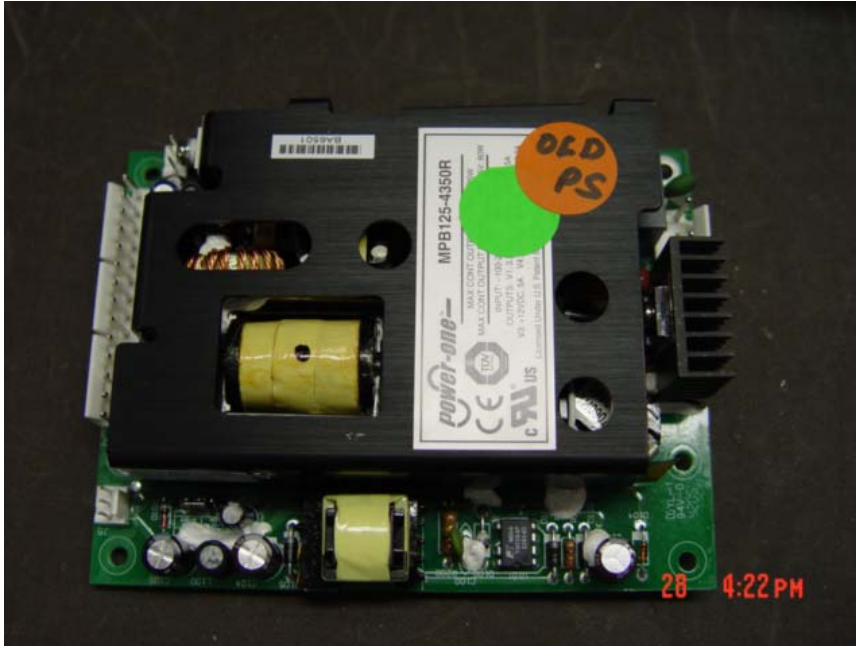
The E4980A specified above serial numbers contain the power supply that might be defective due to a problem in its design by a third company.

The power supply has the sticker on which “OLD PS” is written as shown in the figure below.

Replace the old power supply with the new one (p/n E4980-60103).
