E4980A-01A

S E R V I C E N O T E

E4980A Precision LCR Meter 20 Hz to 2 MHz

Power supply for E4980A might be defective due to its design

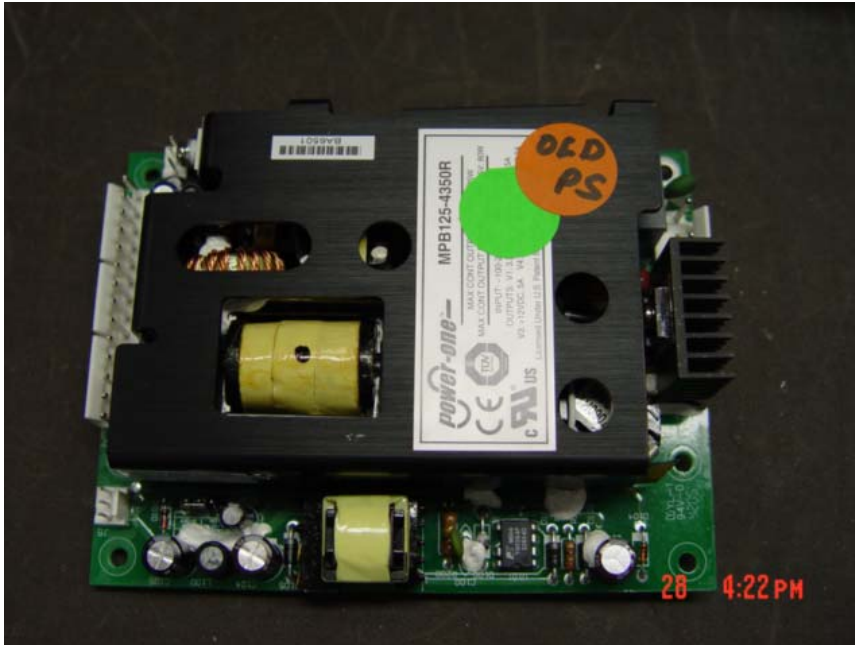
The E4980A specified above serial numbers contain the power supply that might be defective due to a problem in its design by a third company.

For MY46100102 to MY46100134, the power supply has the sticker on which “OLD PS” is written as shown in the figure below.

Replace the old power supply with the new one (p/n 0950-4918).

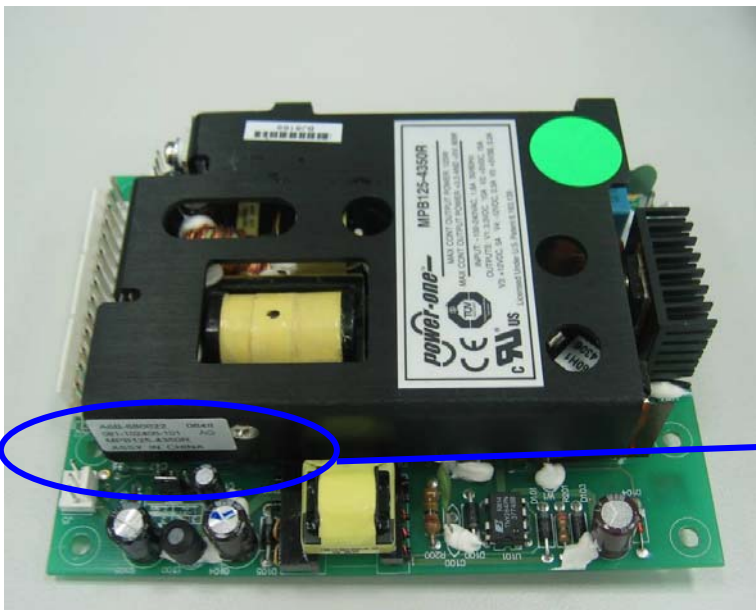
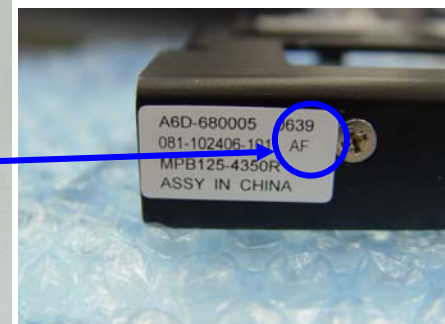
For MY46100889 to MY46101187 and SG46100109, the power supply has the MPN sticker with which revision number suffix is “AF”.
