E4980A-02C-S

Safety Service Note

E4980A Precision LCR Meter, 20 Hz to 2 MHz

POSSIBLE "SHOCK PINCH" HAZARD

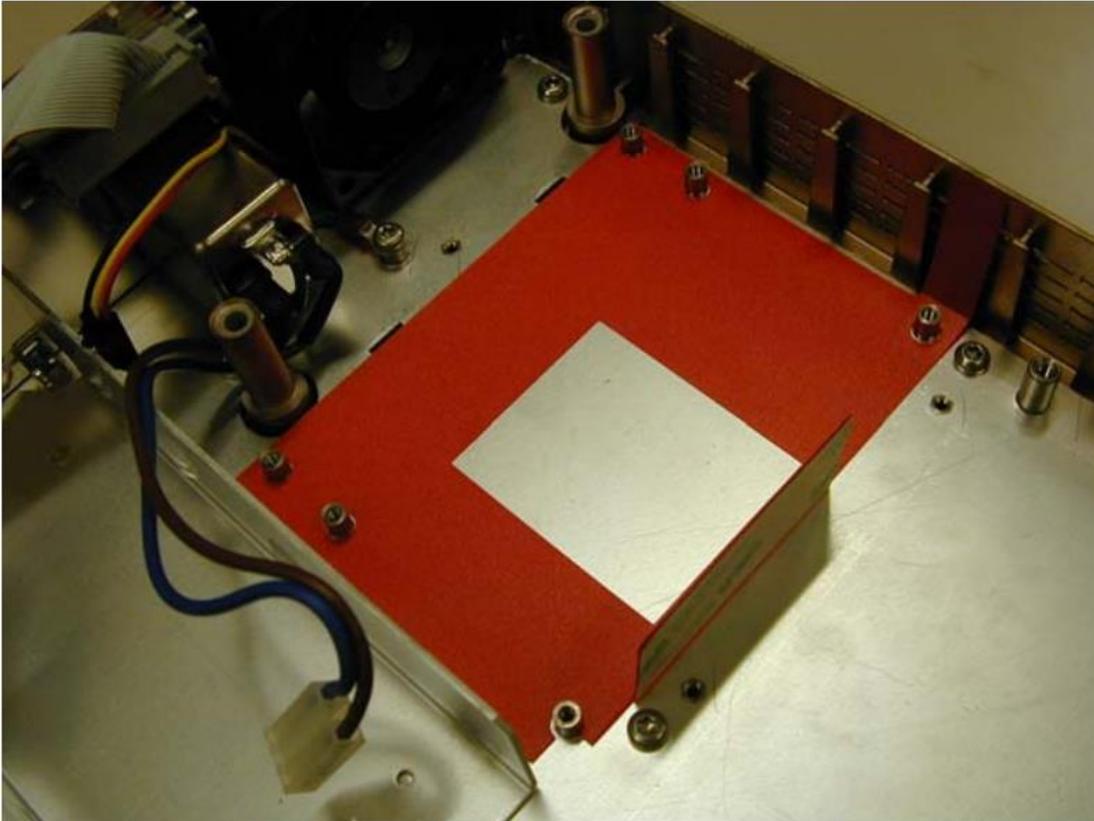
If E4980A LCR meters do not contain an insulator that isolates the primary power signal of the power supply from the chassis of the E4980A. In the worst case, there is a possibility of an electrical shock hazard to the user if the user completes a circuit between the E4980A and another grounded connection while the E4980A is turned on. However, it is an unlikely possibility.

Step2. Put the insulator on base plate as shown in the figure below.
