E4980A-20

Modification Recommended Service Note

E4980A Precision LCR Meter, 20 Hz to 2 MHz

E4980A/AL Keypad Stuck While Using Instrument

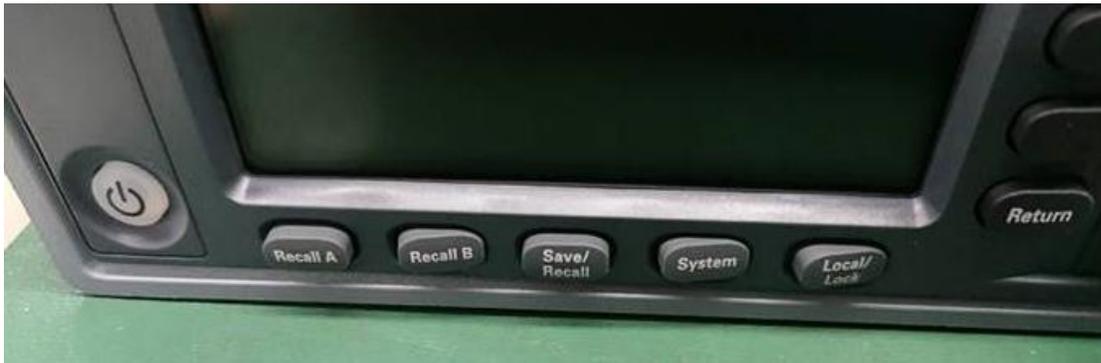
User may find that the instrument's keypad stuck as the picture below while using the instrument. If user reported to have the keypad stuck issue with instrument serial number listed, refer to solution.

The reason behind is that there is issue in supplier's molding causing the front panel to have burr that leads to keypad stuck.

1. Replace front panel E4980-40051.
Refer to Front Panel Assembly Removal in E4980A/E4980AL Precision LCR Meter Service Guide for the procedure to remove and replace the front panel.
2. Power-on the instrument after replacement. Check for any error message or any display failure. Refer to Power On Sequence Troubleshooting in E4980A/E4980AL Precision LCR Meter Service Guide for troubleshooting details.
