E5052A-03

S E R V I C E N O T E

E5052A Signal Source Analyzer

A2 Board Not Seated in the Slot Properly

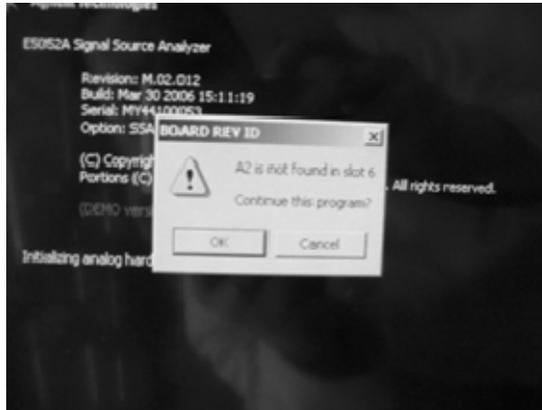
Figure 1 Boot up error message

“A2 not found in slot 6” error message is displayed and E5052A firmware does not start up while windows 2000 operating system has been started. (See Figure 1)

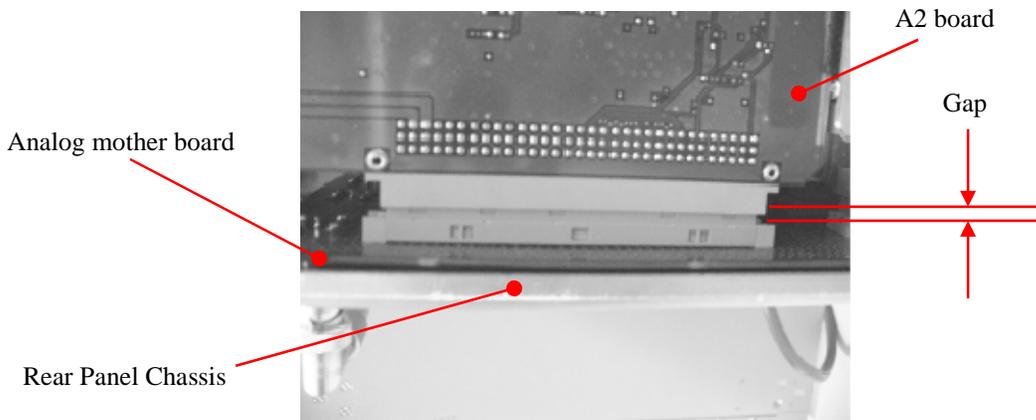
Figure 2 A2 not seated properly (bottom view)

This error is displayed when A2 board is not seated properly and lost the connection to the analog mother board (see Figure 2) due to the flange of both A2 board and chassis is mechanically transformed during transportation (see Figure 3).
