E5053A-01

S E R V I C E N O T E

E5053A 26.5 GHz Microwave Downconverter

Power supply for E5053A might be defective due to its design

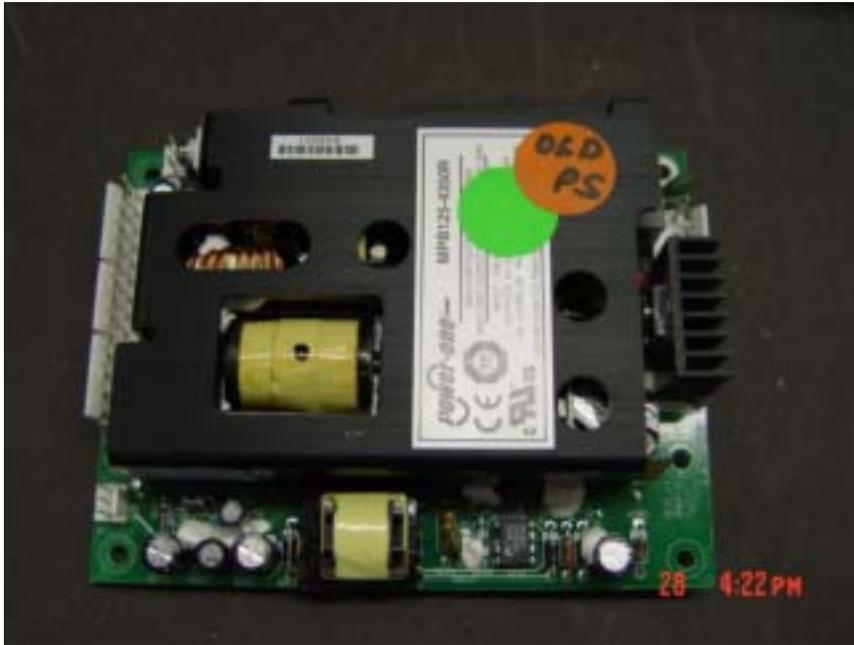
The E5053A specified above serial numbers contain the power supply that might be defective due to a problem in its design by a third company.

The power supply has the sticker on which “OLD PS” is written as shown in the figure below.

Replace the old power supply with the new one (p/n E4980-60103).
