E5061A-04A

S E R V I C E N O T E

E5061A ENA-L RF Network Analyzer, 300 kHz to 1.5 GHz

A2 receiver board fails System Dynamic Range specification due to a very few clock signal generation component might not work properly.

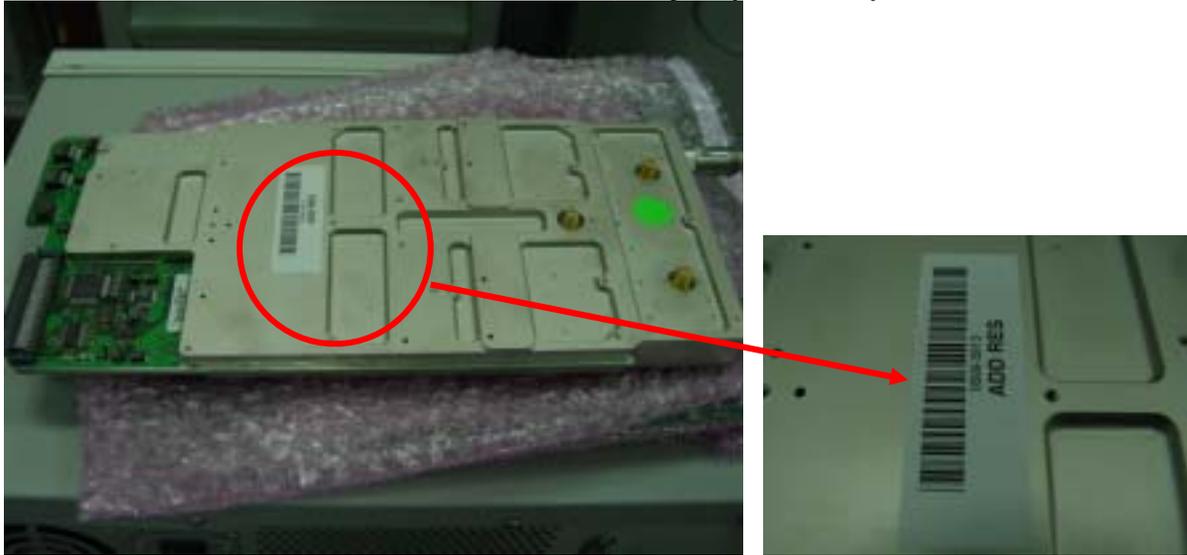
(1) A2 Receiver Module with “ADD RES” sticker. (Temporary solution by AMC)

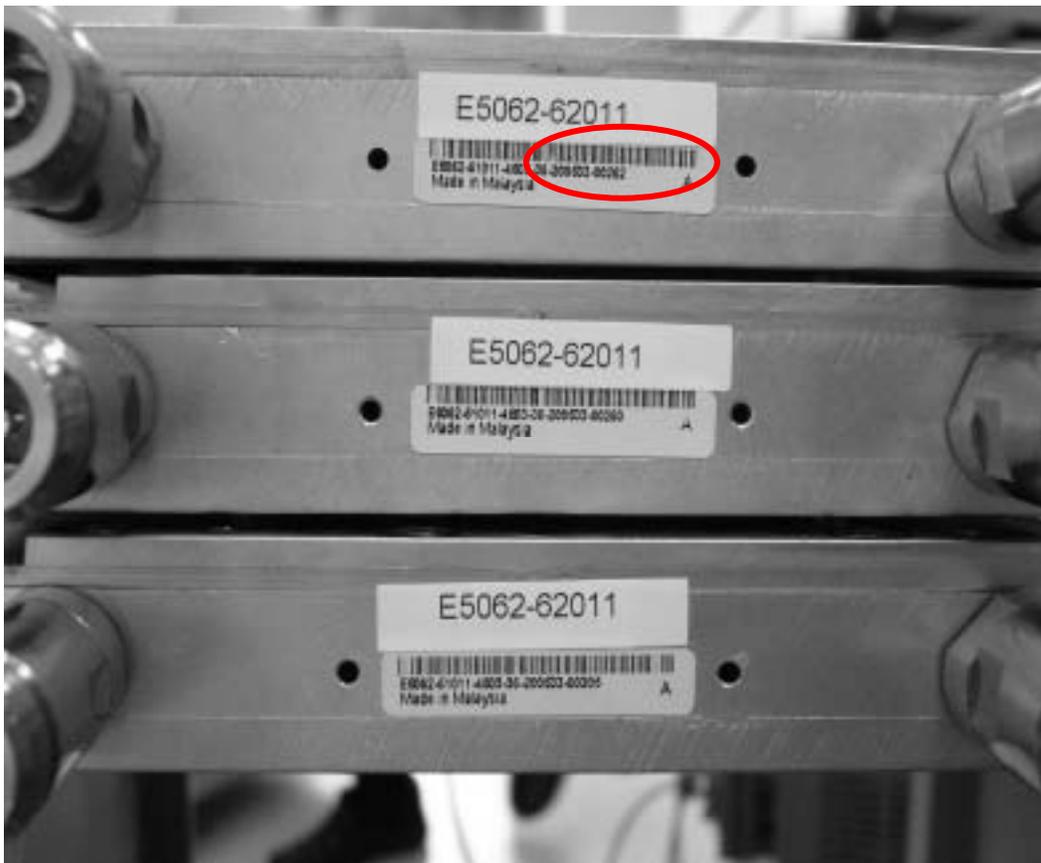
(2) A2 Receiver Module with BARCODE which date code suffix is **-200607**-xxxxxx or later
(Temporary solution by CM)

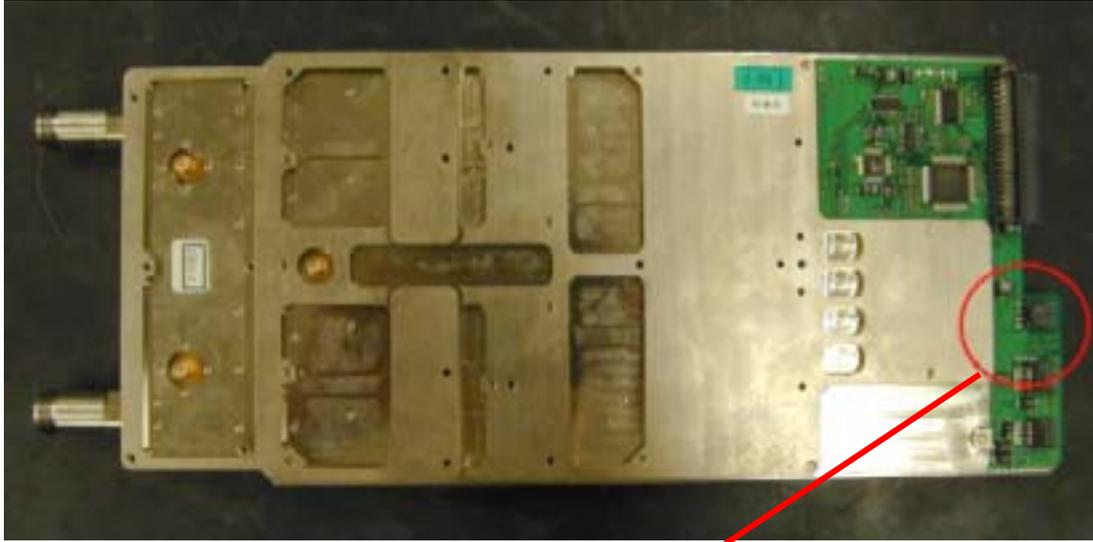
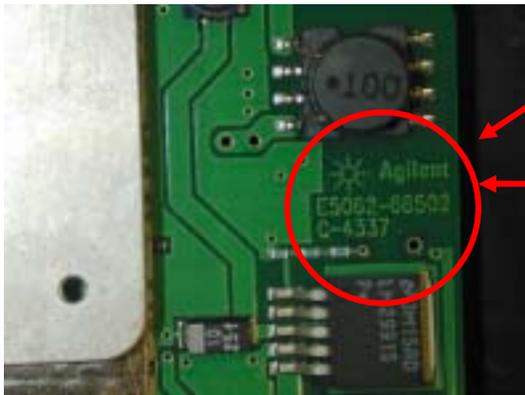
(3) PCA in A2 Receiver Module is changed from E5062-66502 to **E5062-66512**. (Permanent solution)

E5062-66502 should be changed to E5062-66512
