**E5070A-05B**

# **S E R V I C E                      N O T E**

Supersedes:  
E5070A-05A

## E5070A ENA Series Network Analyzer, 300 kHz to 3 GHz

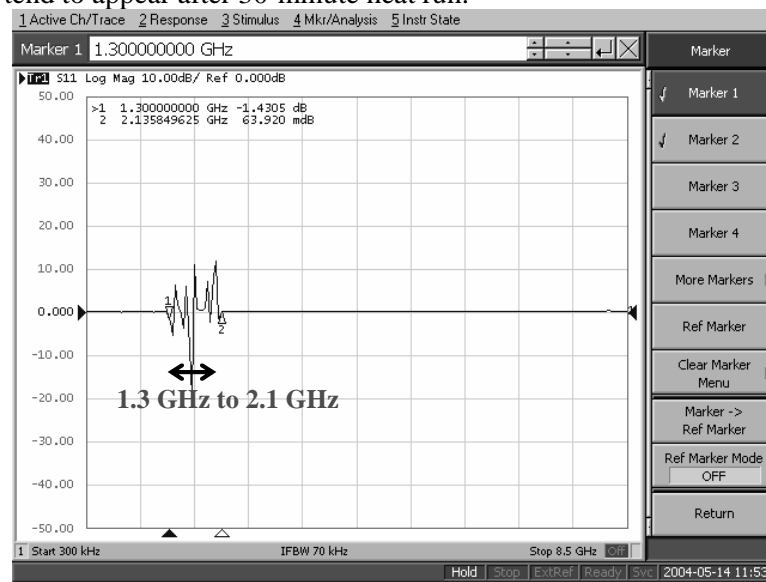
The E5070A and E5071A's A1 source board E5071-6x501, E5071-6x551, and E5071-6x561 module had high-failure rate component parts problem, thus it was re-designed to improve its reliability as E5071-6x571.

When the high-failure rate part has defective, the unit cannot output correct power level source or local signal, between 1.3 GHz and 2.1 GHz frequency range.

Figure 1. Trace shows noise around 1.3 GHz to 2.1 GHz at preset setting.

**When a measurement trace or output power shows troubles between 1.3 GHz and 2.1 GHz, or in full frequency range, replace A1 module with the latest one (E5071-6x571), and update E5070A Operating System at the same time.**

Update the E5070A operating system image referring to the service note E5070A-06B. Then, replace A1 module and perform the appropriate post repair procedures referring to the E5070A/E5071A service manual chapters 6 and 7.

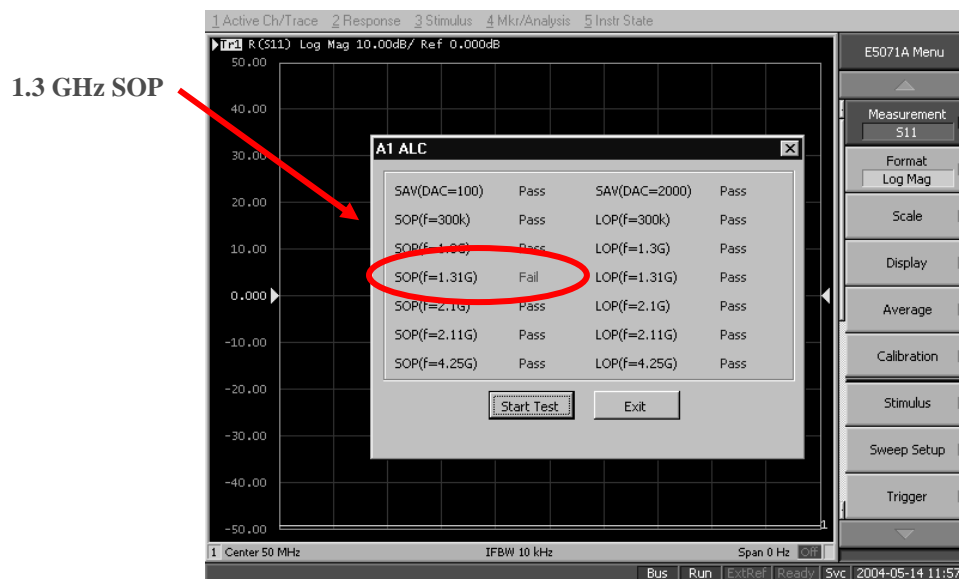
- The trace shows spike at 1.3 GHz or 2.1 GHz at the preset situation.
  - The trace between 1.3 GHz to 2.1 GHz is more noisy than other frequency ranges.
  - The power level of 1.3 GHz to 2.1 GHz is lower than other frequency ranges.
  - Internal test of A1 ALC shows fail at SOP (f=1.3G) or LOP (f=1.3G) as Figure 2.
- Above symptoms tend to appear after 30-minute heat run.

Figure 2. A1 ALC in Internal test has failure at SOP (f=1.3G) or LOP (f=1.3G)
