E5070A-08A**S E R V I C E****N O T E**Supersedes:
E5070A-08**E5070A ENA Series Network Analyzer, 300 kHz to 3 GHz****Serial Numbers: JP1KJ00001 to JP1KJ99999****When E5070A has the step attenuator (33321-60059) and fails Internal Test at Step Attenuator test group, replace the old step attenuator with the improved version (33321-60069) and the revised A86 (E5070-65086).****To Be Performed By: Agilent-Qualified Personnel or Customer****Parts Required:**

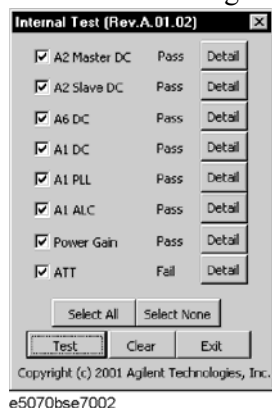
Internal Test dialog box (rev.A01.02 or earlier)

Internal Test is failed on Step Attenuator Test Group, due to the old attenuator reliability.

When the attenuator (33321-60059) is defective, replace with the new replacement attenuator (33321-60069, not 33321-60068) and replace A86 (E5070-66586) with revised one (E5070-65086). There is no need to upgrade firmware for this replacement.
