**E5071A-03**

# **S E R V I C E N O T E**

E5071A ENA Series Network Analyzer, 300 kHz to 8.5 GHz

**Handler I/O Port Malfunction Due to TTL-Low Level Threshold Voltage Anomaly**

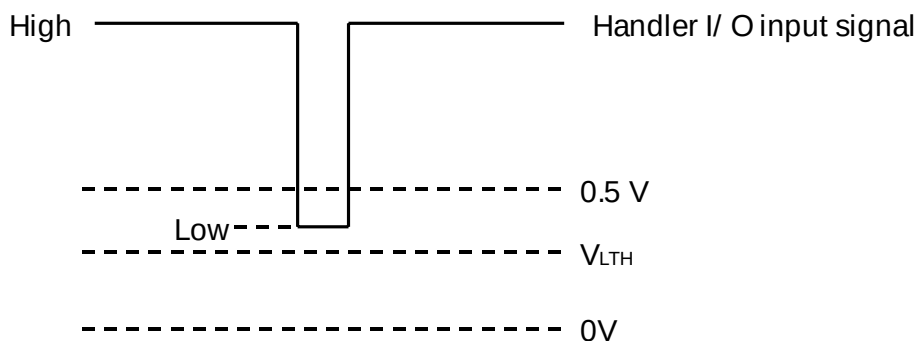
The 24-bit handler I/O of the E5071A units with the specified serial numbers may not function normally. Due to the possible threshold-voltage anomaly of TTL input circuit at either of the I/O pins 2, 18 and 22 through 29, the handler I/O port may ignore the “Low” state of control input signals. When the threshold voltage for TTL-Low level is too low (lower than 0.5 V), it is possible that control input signal does not cross the threshold voltage ( $V_{LTH}$ ) though the “Low” level of the signal is within the recommended voltage range (0 V to 0.5 V). As a result, a handler interface error occurs. See Figure 1.

Figure 1. Threshold voltage anomaly

When the threshold voltage of the handler I/O (either of the I/O pins) is too low, replace the A23 Handler I/O board with new one (P/N E5070-61006).
