E5071A-05B

S E R V I C E N O T E

E5071A ENA Series Network Analyzer, 300 kHz to 8.5 GHz

When a measurement trace or output power shows troubles between 1.3 GHz and 2.1 GHz, or in full frequency range, replace A1 module with the latest one (E5071-6x571), and update E5071A Operating System at the same time.

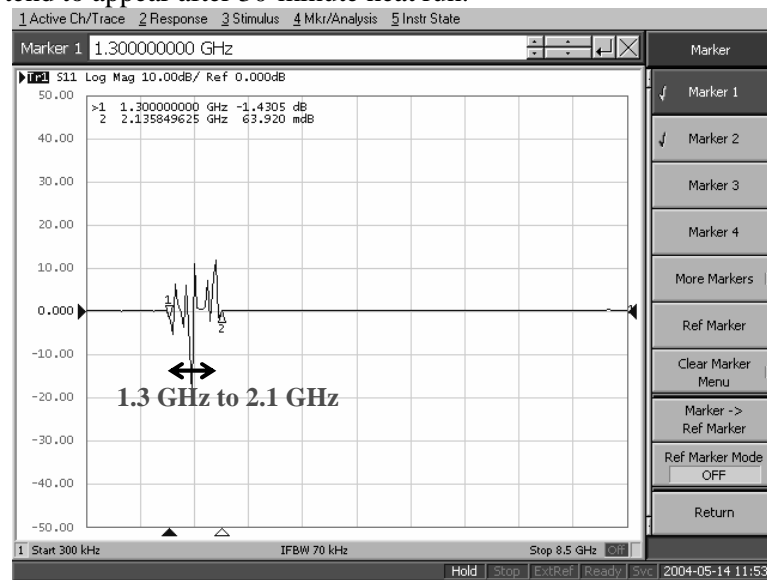
The E5070A and E5071A's A1 source board E5071-6x501, E5071-6x551, and E5071-6x561 module had high-failure rate component parts problem, thus it was re-designed to improve its reliability as E5071-6x571.

When the high-failure rate part has defective, the unit cannot output correct power level source or local signal, between 1.3 GHz and 2.1 GHz frequency range.

- The trace shows spike at 1.3 GHz or 2.1 GHz at the preset situation.
- The trace between 1.3 GHz to 2.1 GHz is more noisy than other frequency ranges.
- The power level of 1.3 GHz to 2.1 GHz is lower than other frequency ranges.
- Internal test of A1 ALC shows fail at SOP (f=1.3G) or LOP (f=1.3G) as Figure 2.

Figure 1. Trace shows noise around 1.3 GHz to 2.1 GHz at preset setting.

Update the E5070A operating system image referring to the service note E5071A-06B. Then, replace A1 module and perform the appropriate post repair procedures referring to the E5070A/E5071A service manual chapters 6 and 7.

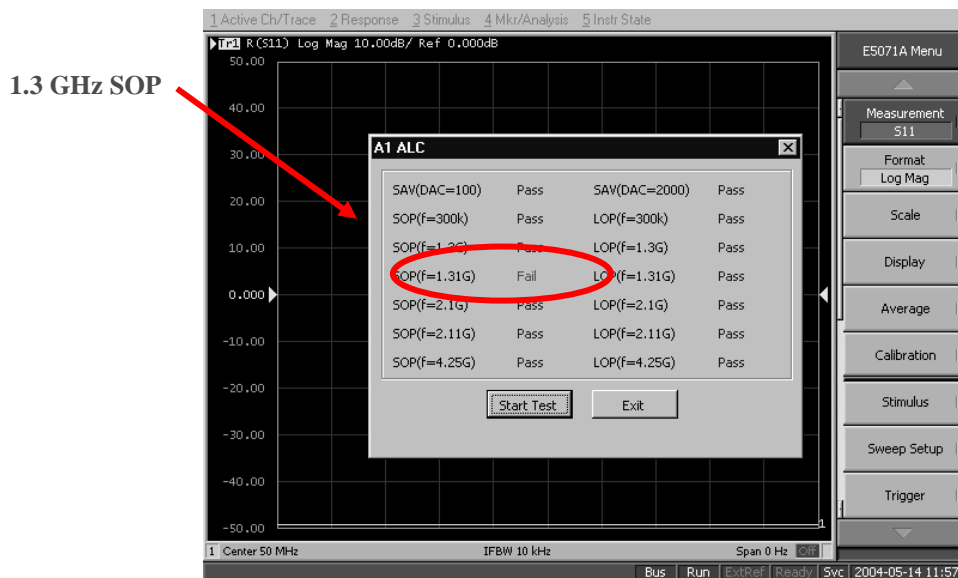
Figure 2. A1 ALC in Internal test has failure at SOP (f=1.3G) or LOP (f=1.3G)
