**E5071B-08C**

# **S E R V I C E                      N O T E**

## **E5071B ENA Series Network Analyzer, 300 kHz to 8.5 GHz**

**When a measurement trace or output power shows troubles between 1.3 GHz and 2.1 GHz, replace A1 module with the latest one (E5071-6x571), and update E5071B Operating system at the same time.**

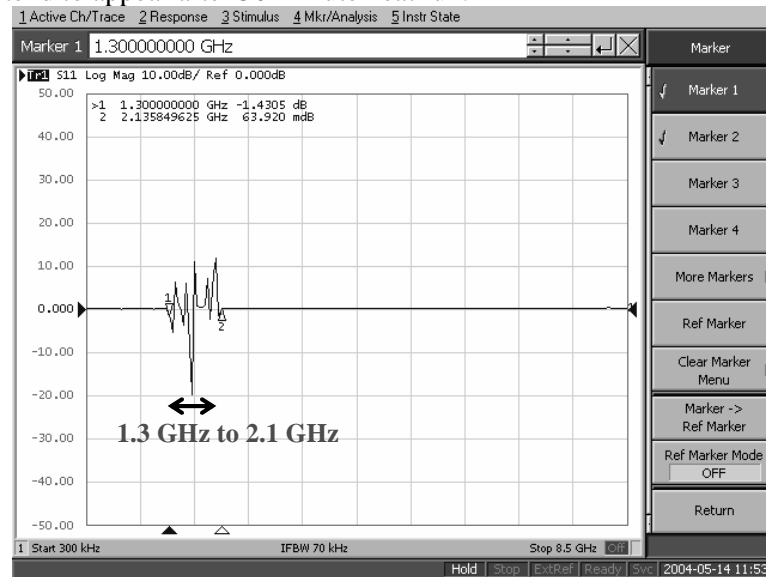
When the high-failure rate part has defective, the unit cannot output correct power level source or local signal, between 1.3 GHz and 2.1 GHz frequency range.

Above symptoms tend to appear after 30-minute heat run.

Figure 1. Trace shows noise around 1.3 GHz to 2.1 GHz at preset setting.

Replace the defective board with E5071-6x571, new A1 module. Also, update the operating system in accordance with the service note E5071B-10A to implement the firmware revision 5.00 or later. \*1

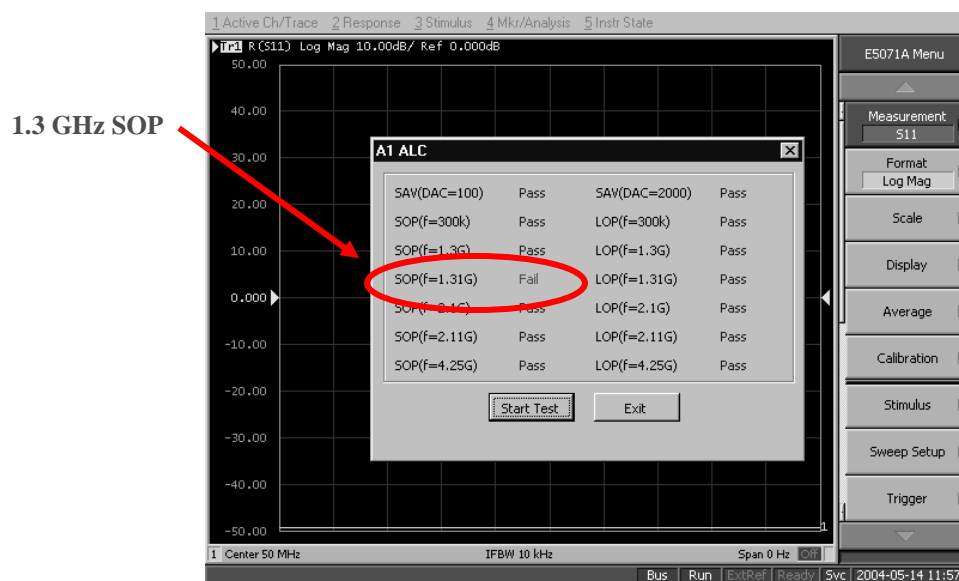
- The trace shows spike at 1.3 GHz or 2.1 GHz at the preset situation.
- The trace between 1.3 GHz to 2.1 GHz is more noisy than other frequency ranges.
- The power level of 1.3 GHz to 2.1 GHz is lower than other frequency ranges.
- Internal test of A1 ALC shows fail at SOP (f=1.3G) or LOP (f=1.3G) as Figure 2.

Figure 2. A1 ALC in Internal test has failure at SOP (f=1.3G) or LOP (f=1.3G)
