## E5071B-12D

# S E R V I C E                      N O T E

## E5071B RF Network Analyzer, 300kHz to 8.5 GHz

**When E5071B has the old step attenuator (33321-60059) and Internal Test fails at Step Attenuator Test Group, replace the old attenuator (33321-60059) by improved version (33321-60068), add additional cable and update firmware to 5.02 or later**

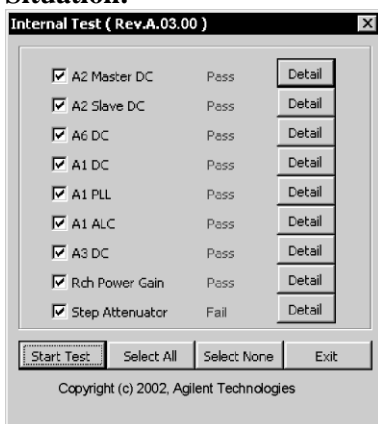
e5070bse139\_3

Internal Test is failed on Step Attenuator Test Group, due to the attenuator reliability.

When the attenuator (33321-60059) is defective, use new replacement attenuator (33321-60068) and cable (E5070-61698). Make sure that Firmware 5.02 or later is installed.
