E5071C-06

S E R V I C E N O T E

E5071C ENA Series Network Analyzer, 9 kHz to 20 GHz

The S11 trace shows strange spurs at 68M to 2.1G, when the E5071C operator changes stop frequency to 6G, 6.5G, 7G etc.

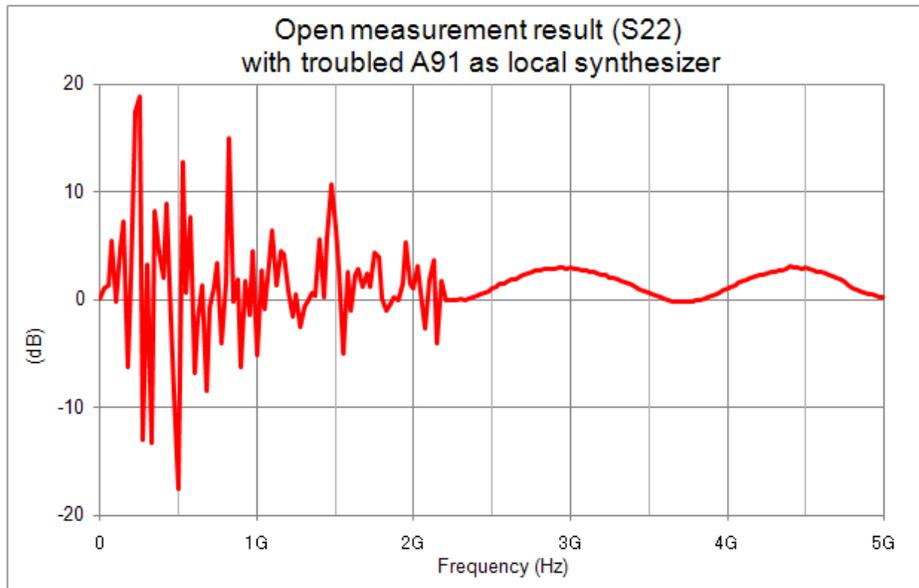
Shortly after turning on the E5071C and then “Preset” key pressed, the S11 is fine. But when the E5071C operator changes stop frequency to 6G, 6.5G, 7G etc., the S11 trace shows strange spur at 68M to 2.1G. (The stop freq point varies around 4.39G to 7.0G)

The same symptom occurs on S22, S33 and S44.

The below is a sample failure symptom on S22.

1. Replace two synthesizer boards (item 4 at the below picture) for Local and Source.

2. Perform the required Adjustment and Perform Verification which is described at Post-Repair Procedures in the service manual.
