E5071C-26

S E R V I C E N O T E

E5071C - ENA Series Network Analyzer, 9 kHz to 8.5 GHz

Phase shifts 180 degree, due to the mixture of RoHS receiver board and non-RoHS receiver board

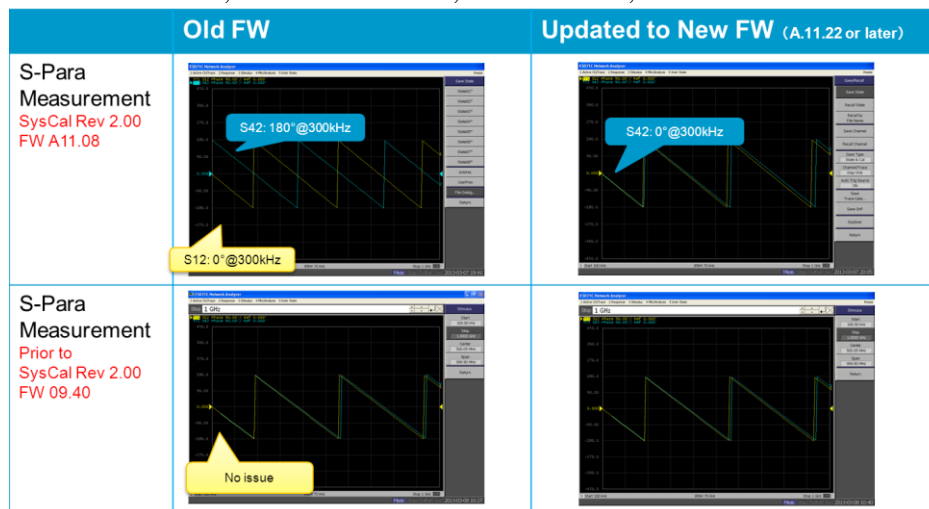
Example-1

1. Identify RoHS receiver port(s) and non-RoHS receiver port(s).
2. Connect Thru cable between one of RoHS receiver port and one of non-RoHS receiver port.
3. After preset, select transmission measurement on the test ports and measurement format phase.
4. If phase is around 180° at the lowest frequency, it's faulty

Port-1: non-RoHS, **Port-2: non-RoHS**, Port-3: RoHS, **Port-4: RoHS**

If there is a mixture of RoHS receiver board(s) and non-RoHS receiver board(s), update Firmware to A.11.22 or later

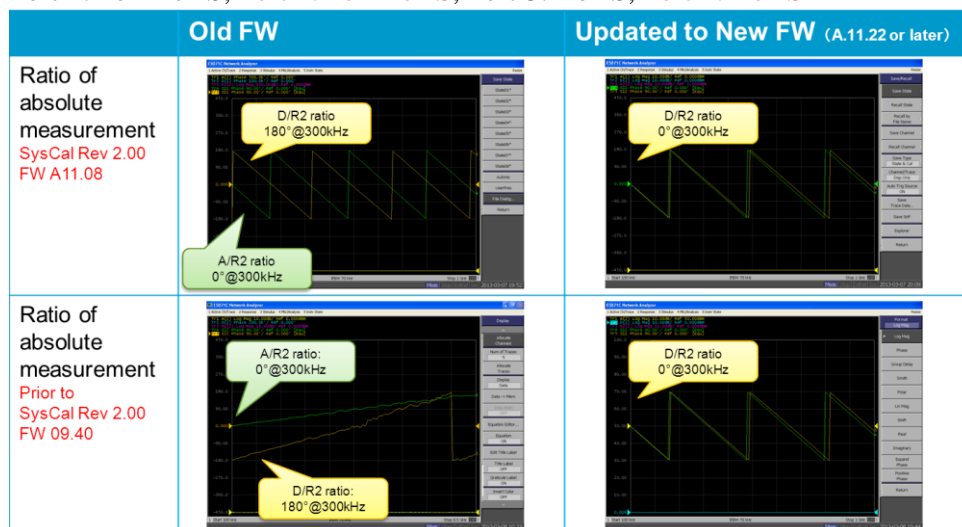
Example-2

1. Identify RoHS receiver port(s) and non-RoHS receiver port(s).
2. Connect Thru cable between one of RoHS receiver port and one of non-RoHS receiver port.
3. After preset, show 3 traces.
4. Set measurement parameter and format as below;
 Trace1: Absolute measurement R-ch of non-RoHS Receiver port
 Trace2: Absolute measurement T-ch of RoHS Receiver port
 Trace3: Trace2/Trace1 with Equation editor function, set format Phase.
5. If phase is around 180° at the lowest frequency, it's faulty

Port-1: non-RoHS, **Port-2: non-RoHS**, Port-3: RoHS, **Port-4: RoHS**
