E5071C-54

Modification Recommended Service Note

E5071C ENA Series Network Analyzer, 9 kHz to 20 GHz

E5071C SSD SATA Cable Installation Enhancement for Fixed Data Storage (Opt-019)

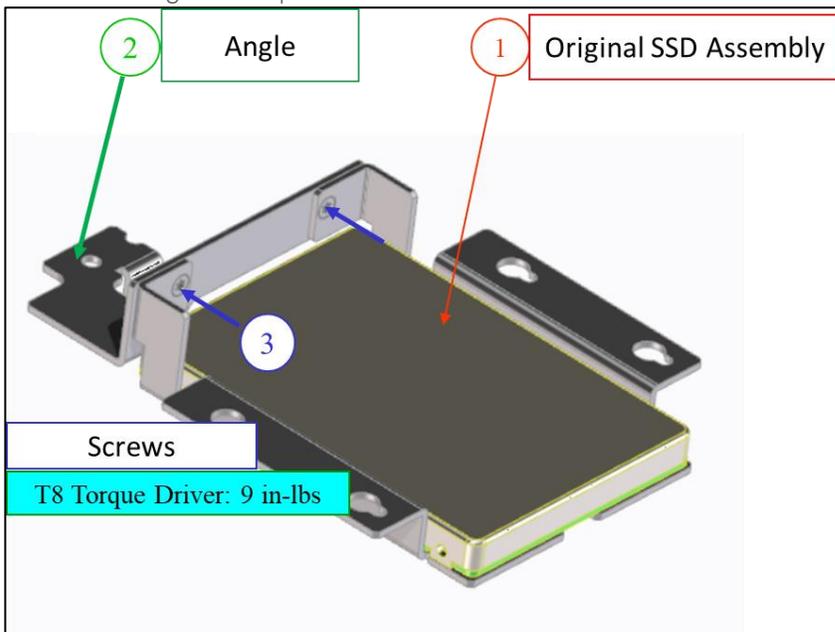
In some unlikely situation, the SSD (Solid-State Drive) SATA (Serial ATA) cable will become loose when the cable is pushed downwards. This is due to the Micron 1100 SSD connector latch design.

1. Remove the E5071C casing. Refer to service guide chapter 6 – Outer Cover Removal.
2. Remove the SSD assembly.
3. Install the angle as depicted. Fasten the two screws.
