# Modification Recommended Service Note

## E5080B ENA Series Network Analyzer

Serial Numbers: MY59300001-MY59399999, SG59300001-SG59399999  
Manufacturing ID Number: NA

Acoustic sound from PSU

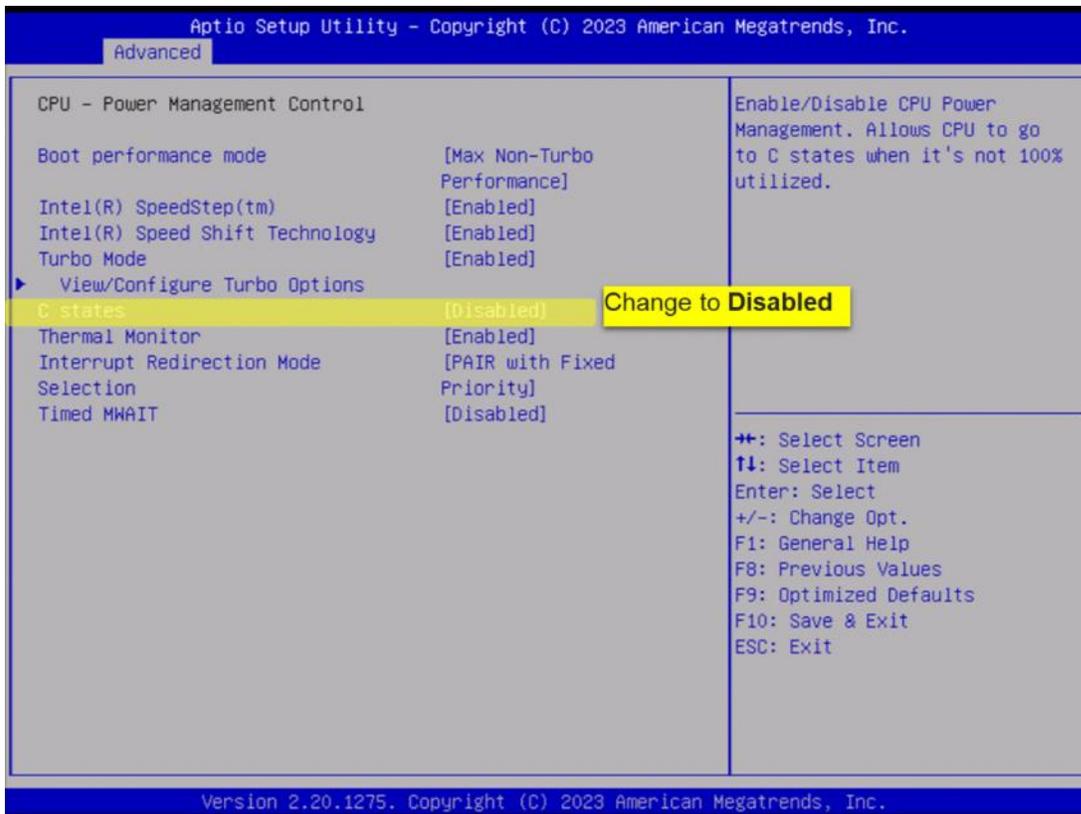
E5080B ENA units with serial number range beginning with MY593xxxxx may produce acoustic sound when they are powered on or during operation. It is crucial to note that this sound does not impact performance, quality, reliability, or functionality.

This phenomenon results from the combination of the Gen 2 CPU with the power supply unit. Replacing the CPU with Gen 1 CPU resolves the acoustic sound.

1. Connect a USB keyboard to E5080B.
2. Power on the ENA.
3. Press ESC/ DEL key repeatedly to enter BIOS setting page.
4. Select Advanced > Power & Performance > CPU – Power Management Control > C states > **Disabled**. Set the C states value from Enabled to Disabled.
5. Press ESC key twice
6. Select Save & Exit > Save Changes & Exit
7. Select Yes at Save Configuration & Exit?
8. Reboot the system.
9. Monitor if the acoustic/ tickling sound reduces to user acceptable level.
