E5515C-05C

S E R V I C E N O T E

E5515C Wireless Communications Test Set (8960 Series)

Power-On DSP Initialization Failures Require Replacement of the DSP Assembly

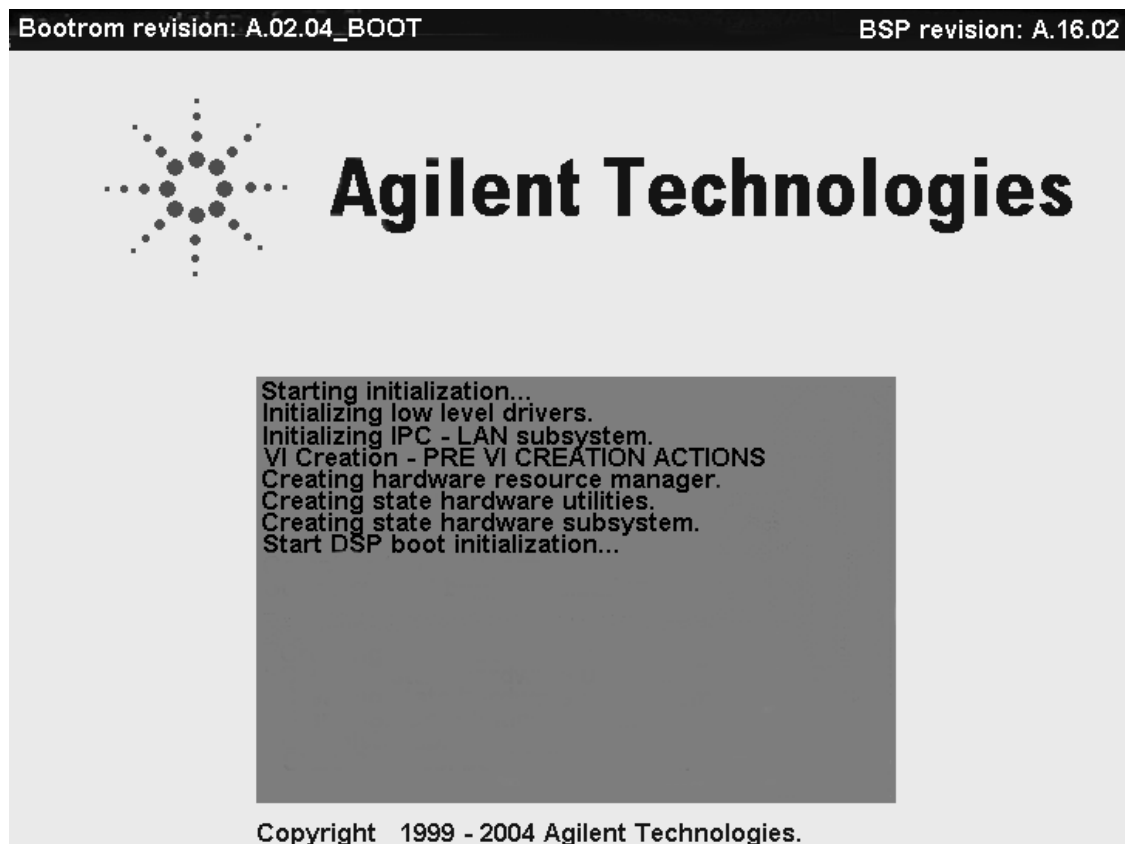
- **Figure 1** shows the typical point in the test set bootup process where the DSP fails to initialize. The bootup process may stop here and then re-boot, or will eventually complete the bootup process after multiple attempts to initialize the DSP assembly.

Figure 1 – DSP initialization bootup failure during test set power-on.

If the test set fails to bootup correctly, takes longer than normal to bootup, or displays messages noted below, replace the DSP Assembly using exchange repair kit E5515-69843. Verify that the test set boots up and operates normally. Re-calibration is not required.
