**E5515C-06B**

## **E5515C Wireless Communications Test Set (8960 Series)**

**Serial Numbers: GB42360000/GB44059999**

### **Boot Up Failures at Power-On Require Replacement of 10 GB Hard Disk Drive (HDD)**

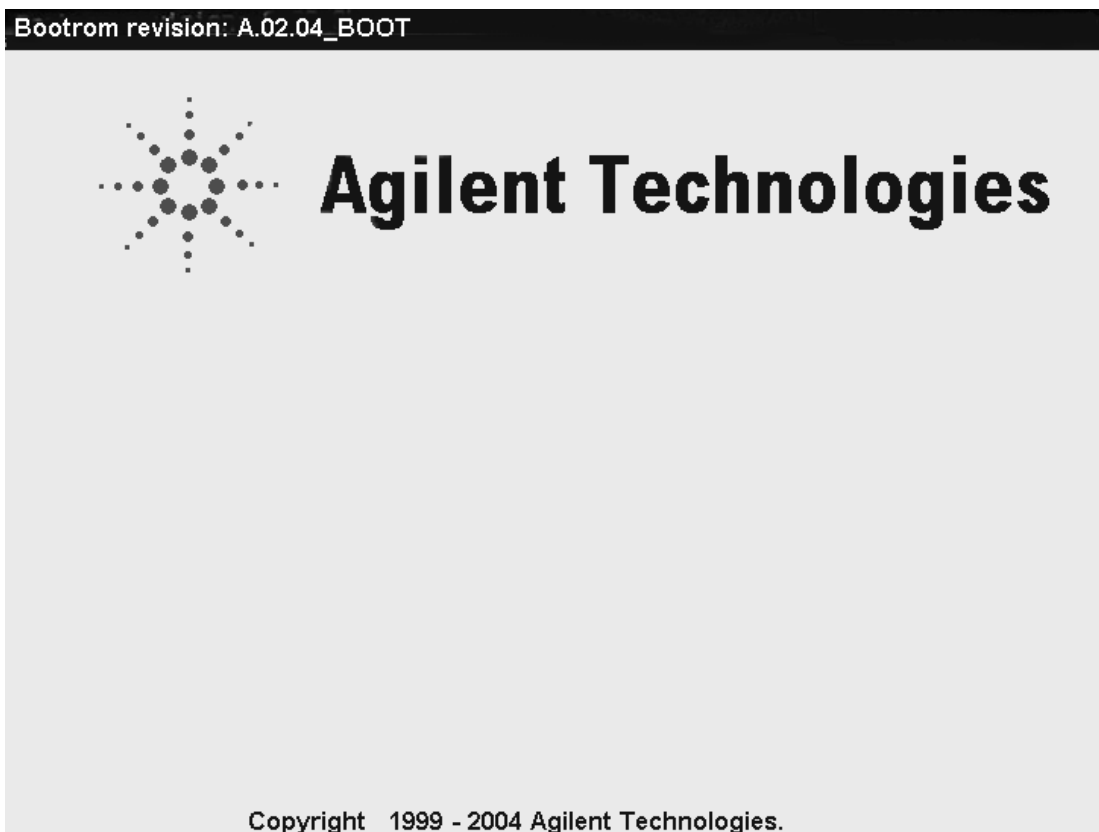
- **Figure 1** shows the typical point in the test set bootup process where the HDD fails to initialize. Note that the BSP Revision code is not displayed in the upper right corner of the display. A typical failing 10 GB HDD will show this screen intermittently in the first stages of failure.

A defective Channel Control chip on the HDD control circuitry is the main source of failures. This chip controls the read/write function to and from the HDD. The failure mechanism is accelerated with elevated ambient temperature and humidity (above 80 deg F and 80% relative humidity). Replacement HDDs (20 GB) have been re-designed to correct this problem.

**Figure 1 – HDD failure during test set power-on (BSP code not loaded from HDD to RAM).**

If the test set fails to bootup correctly replace the HDD using repair kit E5515-61833 (which uses a 20 GB HDD). You must provide the model number and serial number of the test set when placing an order for this repair kit.
