E5515C-12

**S E R V I C E N O T E**

E5515C Wireless Communications Test Set (8960 Series)

Serial Numbers: MY48360101 to MY48363048.....and E5515C with an upgraded Rear Panel (E5515-60537)

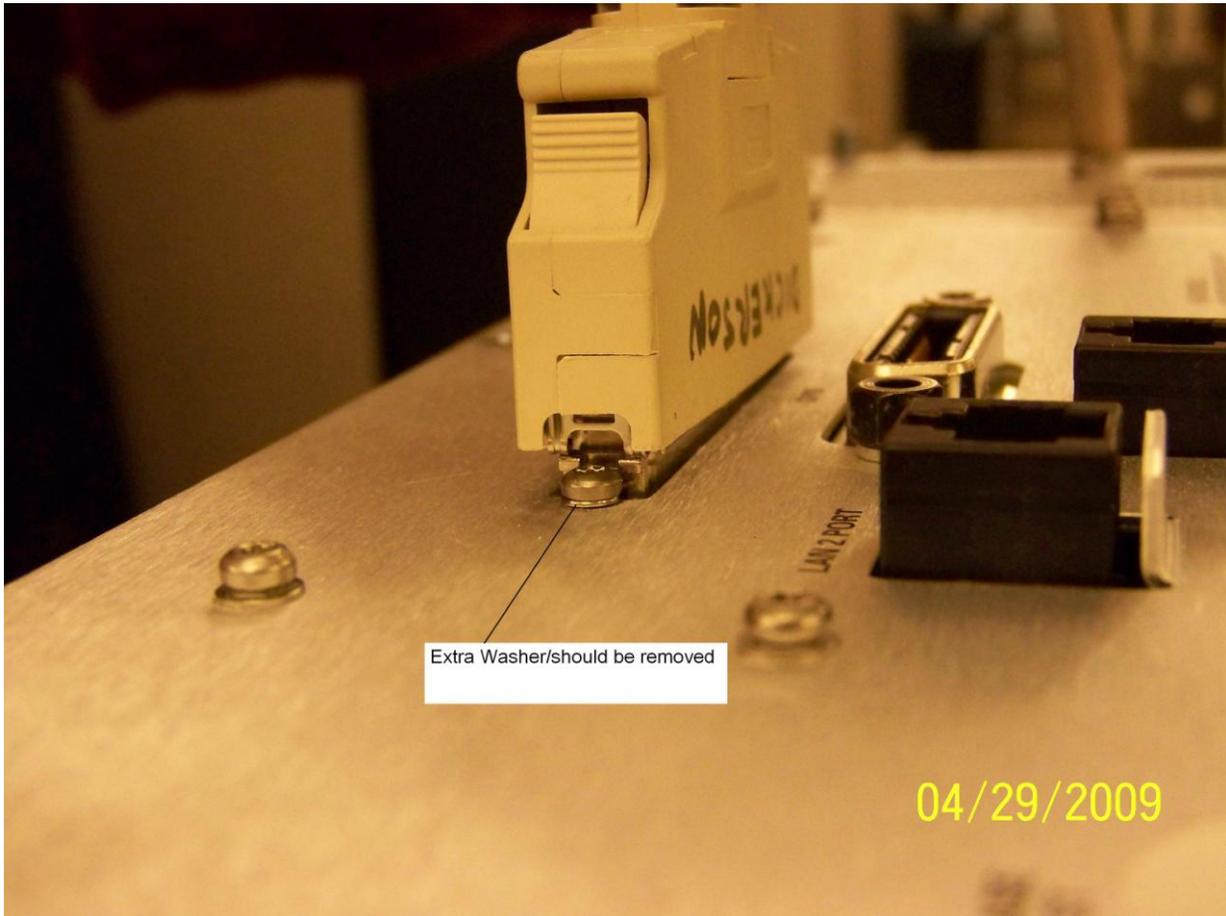
Figure 1

The locking clips on the Digital Bus plug will not engage to the rear panel Digital Bus connector. The failure is due to an extra washer that was mistakenly added under the screw on the rear panel connector that prevents the locking clips from engaging.

Fail to mate the cable on the rear panel “digital bus” connector, the failure is due to an extra washer(x2) to be added on rear panel, it causes the connector can not settle on the right position. see picture below:

Check the instruments which are in SSU for service and remove the washer(x2) if it is found. or guide the user to perform the modification by qualified person.

1. Remove the outer cover and top cover for the 8960
2. Remove the Host Processor and Protocol Processor Modules
3. Loosen the two screws connecting the digital bus connector (see Figure 1).
4. Remove the two “extra washers”, then re-attach the digital connector
5. Reinstall the modules and covers.
