E5515C-14

S E R V I C E N O T E

E5515C Wireless Communications Test Set (8960 Series)

2 Missing Washers on the DSP Fan Assembly Requires Replacement of the 5.8 DSP Board

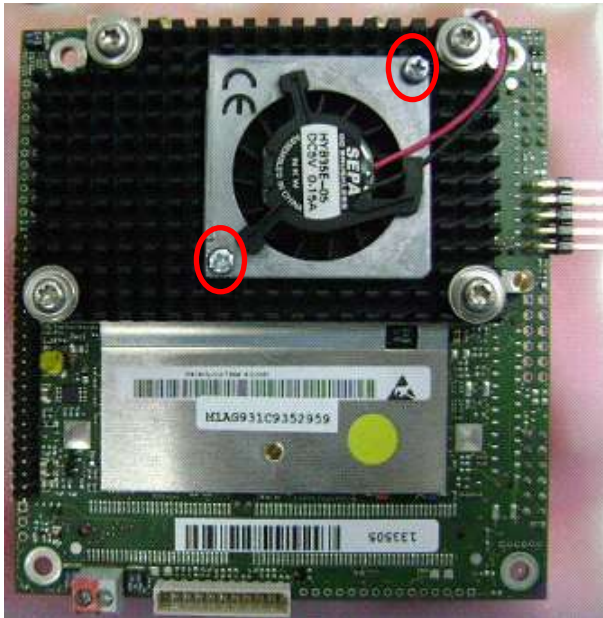
Figure 1: Washer locations

The two washers are located on the DSP fan assembly as shown in the picture below. The washer sits in between the screw head and fan assembly metal work.

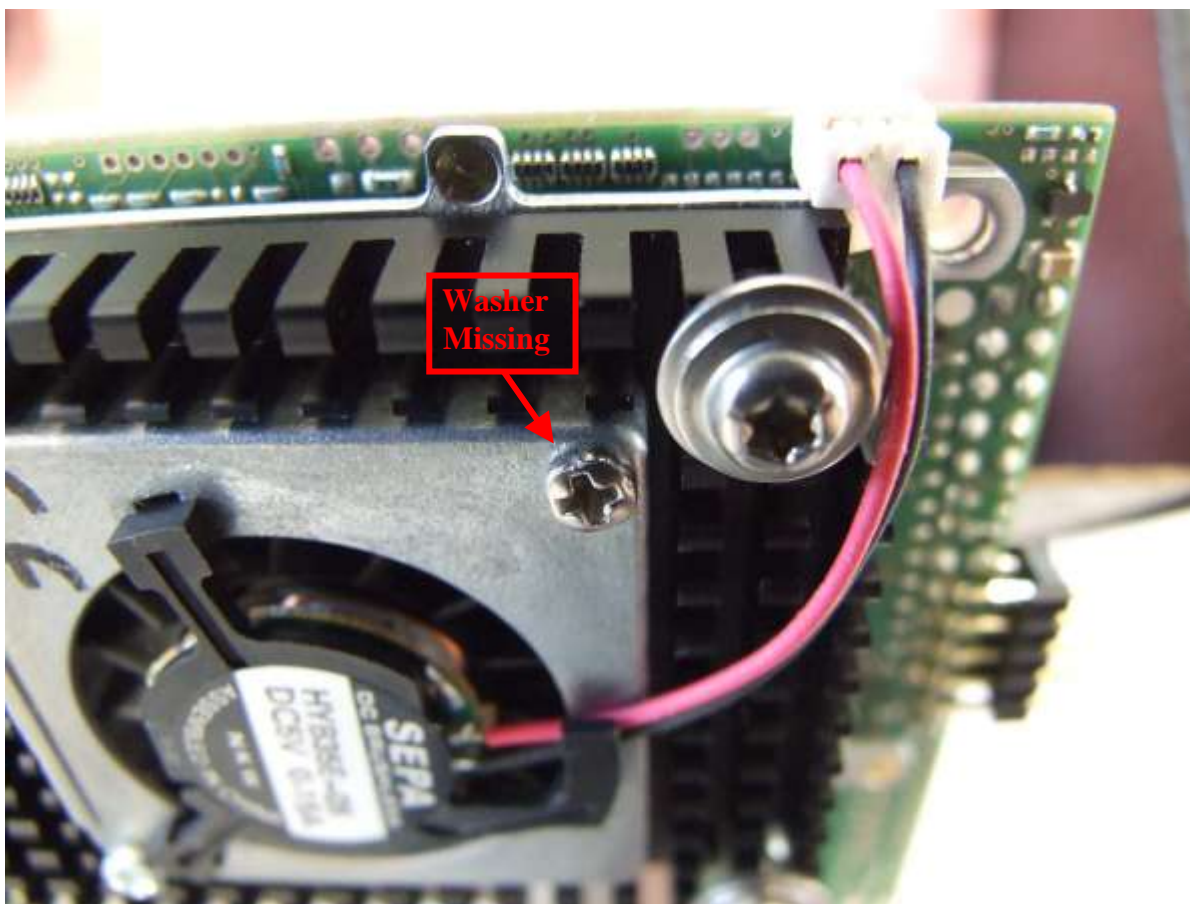
Figure 3: Washer Missing

Although not all DSPs may exhibit errors, the most common failures during operation due to the missing washers are boot up failures and intermittent non-recoverable DSP asserts.

Without the washers, the screws bottom out and lift the heat sink from the sheet metal below, causing an air gap, less cooling effect and therefore a hotter running DSP which will eventually fail.

If the 5.8 DSP fan does not have the washers, replace the DSP Assembly using the repair kit E5515-61845. Verify that the test set boots up and operates normally. Re-calibration is not required.
