E5515C-14B

N O T E

E5515C Wireless Communications Test Set (8960 Series)

New design DSP board to replace failures on 8960 instruments upgraded to 5.8.

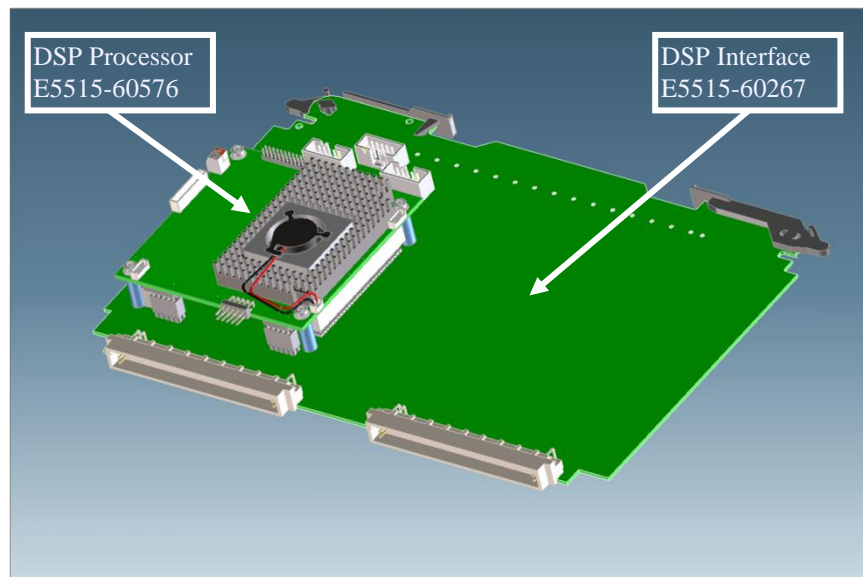
There has been an increase in failures on the E5515C due to the 5.8 version of DSP, assembly part number E5515-61301.

The DSP failure is due to a weak thermal design that, in some situations, can lead to a thermal stress failure most notably in year 2 and year 3 of life in high ambient temperature environments ie within test racks with little or no air conditioning.

E5515-61301 – Existing 5.8 DSP Assembly with potential fault (note the integrated fan)

At the time of failure, the whole DSP assembly should be swapped with a new DSP which has been designed for improved reliability.

At the same time, an additional fan should be added to the Power Supply to enhance the airflow across the DSP and further reduce the thermal stress.

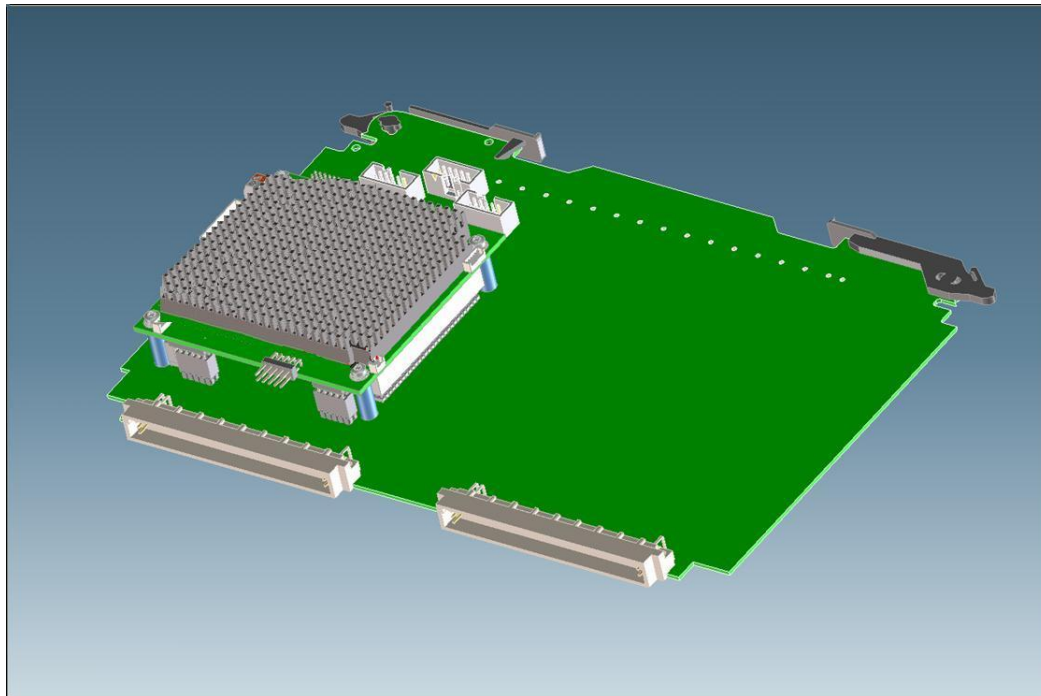
New DSP Assembly (note the larger heatsink *without* the integrated fan)

3. Use the repair kit E5515-61885 to replace the DSP
