E6198B-01

Modification Recommended Service Note

E6198B Keysight Switch/Load Unit (SLU)

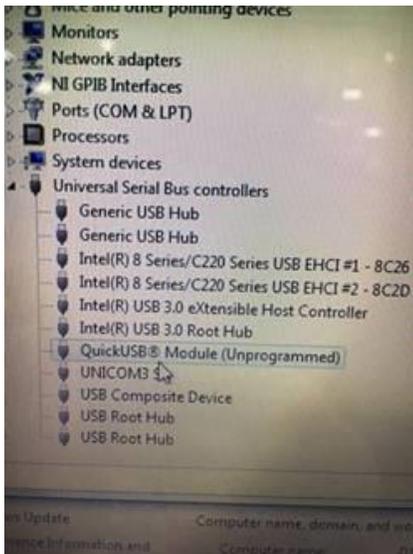
To check the version of the existing QuickUSB driver, go to "Device Manager" -> under "Universal Serial Bus controllers" -> QuickUSB Module (right click) -> select "Properties"

Update QuickUSB driver to version 2.15.2.
