E7340A-01

S E R V I C E N O T E

E7340A Network Analyzer System

Serial Numbers: US00000000/US99999999

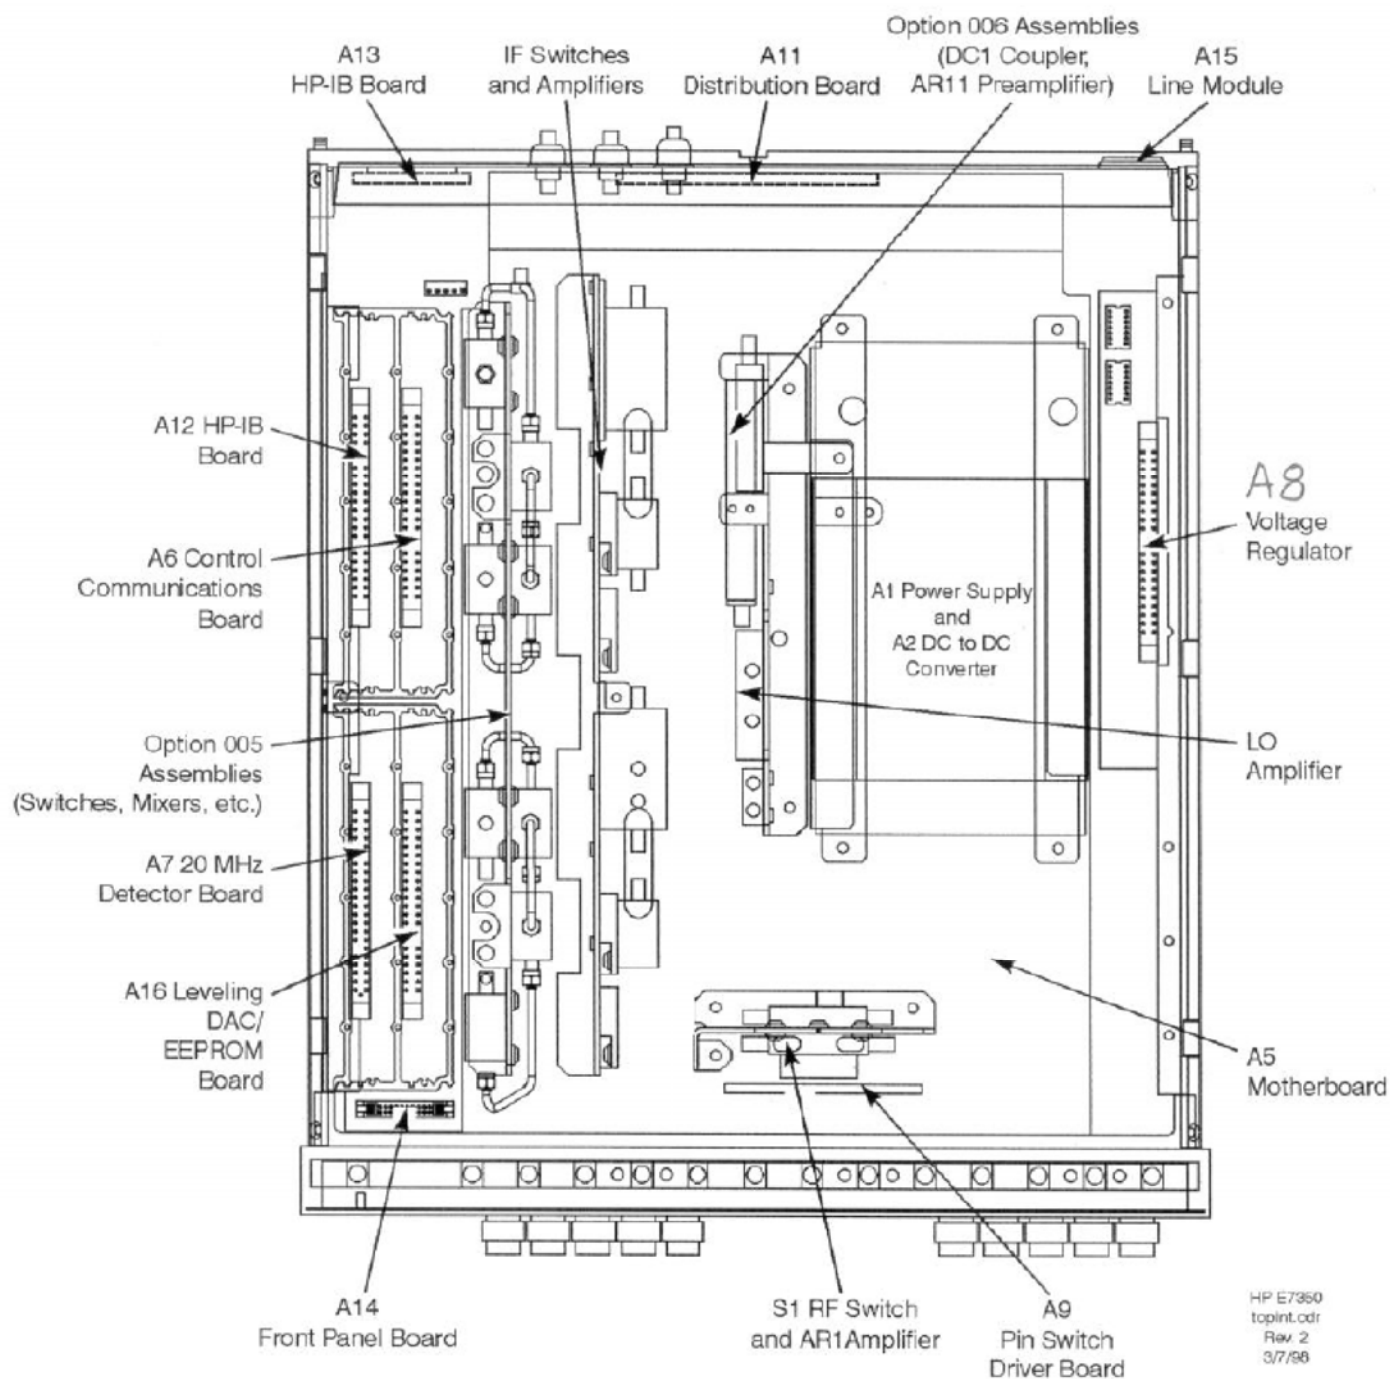
Figure 6-2 Assembly Locations within the Controller

MM Controller	Part Number	Price	Reference
Amplifiers:	**	**	8510XF Manual, part # E7350-90001, page 5-27:
AR1	5086-7650	\$3,216	E7350 block diagram 3 of 3
AR6	0955-0612	\$804	E7350 block diagram 3 of 3
AR12	0955-0612	\$804	E7350 block diagram 3 of 3
AR13	0955-0612	\$804	E7350 block diagram 3 of 3
Switches:	**	**	8510XF Manual, part # E7350-90001, page 5-27:
S1	85332-60005	\$3,398	E7350 block diagram 3 of 3
S2	0955-0778	\$303	E7350 block diagram 3 of 3
S3	0955-0778	\$303	E7350 block diagram 3 of 3
S4	0955-0778	\$303	E7350 block diagram 3 of 3
S5	0955-0778	\$303	E7350 block diagram 3 of 3
Board Assemblies:	**	**	8510XF Manual, part # E7350-90001, page 6-10:
A6, Control Communication Board	E7340-60014	\$186	Figure 6-2, Assembly location (see page 3 in this Service Note)
A7, 20 MHz Detector Board	E7340-60015	\$1,336	Figure 6-2, Assembly location (see page 3 in this Service Note)
A8, Regulator Board	E7340-60016	\$606	Figure 6-2, Assembly location (see page 3 in this Service Note)

A12, GPIB-XF Board	E7340-60103	\$591	Figure 6-2, Assembly location (see page 3 in this Service Note)
A16, Leveling DAC Board	E7340-60094	\$303	Figure 6-2, Assembly location (see page 3 in this Service Note)
MM Heads (Left & Right Head are same)	**	**	**
Amplifiers:	**	**	8510XF Manual, part # E7350-90001:
AR1	5087-7016	\$2,171	E7350 block diagram 2 of 3, page 5-25
AR4	5086-7983	\$2,063.37	E7350 block diagram 1 of 3, page 5-23
AR5	5086-7983	\$2,063.37	E7350 block diagram 1 of 3, page 5-23
AR6	5086-7650	\$3,216	E7350 block diagram 1 of 3, page 5-23
Switches:	**	**	8510XF Manual, part # E7350-90001:
S1	5086-7589	\$2,172	E7350 block diagram 1 of 3, page 5-23
Board Assemblies:	**	**	**
Bias Board Assembly (see note below)	5063-1671	\$96.20	See graphic of MM Head on page 4 in this Service Note
Note: U11, 5086-7994, V-band doubler includes Bias Board & Doubler assembly.			
Doubler assembly rarely fails but the bias board attached to it has high failure rate.

This Service Note provides information on the frequently failed parts in the controller and mm heads of the 8510XF. Customers may want to buy spare parts now, since they may not be available after April 1, 2009.
