**E7350A-01****S E R V I C E N O T E**Supersedes:  
None**E7350A Network Analyzer System****Serial Numbers: US00000000/US99999999**

**Spare parts for the controller and mm heads of the 8510XF (includes all associated models, upgrades, and most accessories) may not be available after April 1, 2009, when service support ends. This Service Note provides information on frequently failed parts so that customers can stockpile parts they may need in the future.**

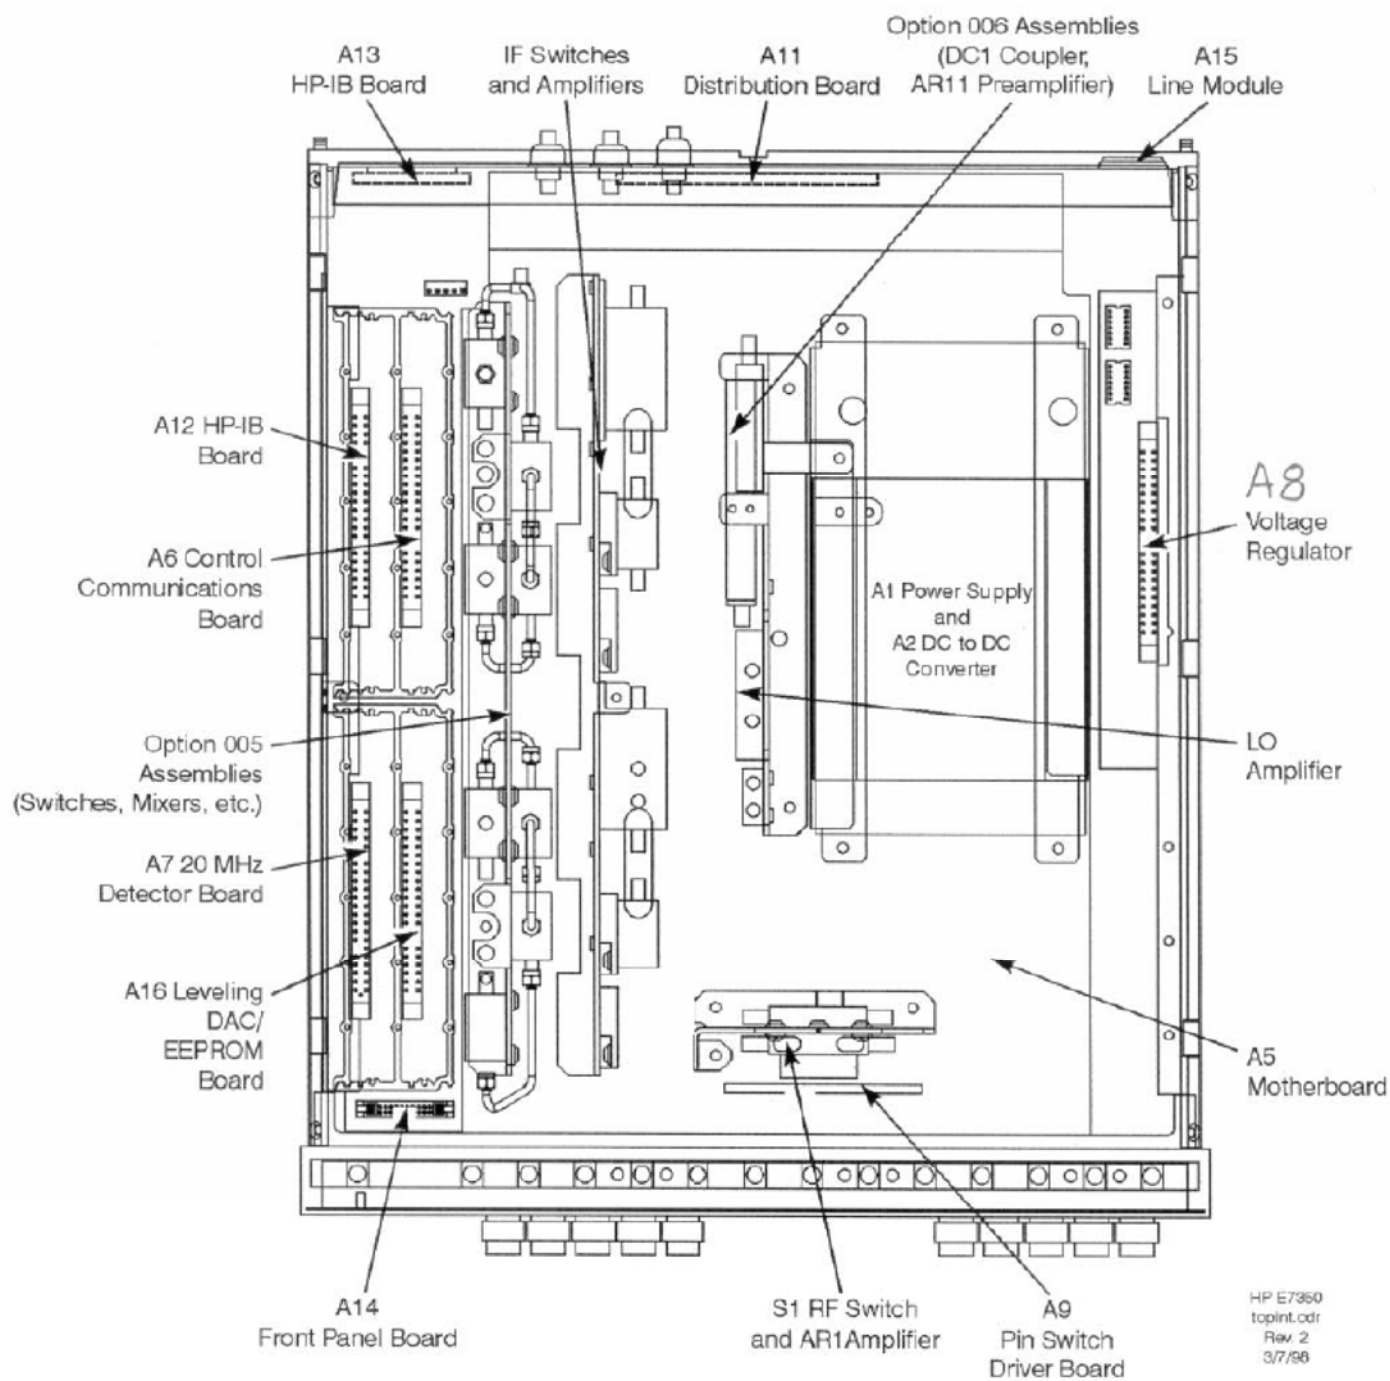
**Figure 6-2 Assembly Locations within the Controller**

The following list of frequently failed parts comes from 8510XF return to factory (RTF) repair data accumulated over five years. The parts with high failure rates are high power amplifiers, switches, and board assemblies in the MM controller and MM Heads.

| <b>MM Controller</b> | <b>Part Number</b> | <b>Price</b> | <b>Reference</b> |
|---|---|---|---|
| A6, Control Communication Board | E7340-60014 | \$186 | Figure 6-2, Assembly location (see page 3 in this Service Note) |
| A7, 20 MHz Detector Board | E7340-60015 | \$1,336 | Figure 6-2, Assembly location (see page 3 in this Service Note) |
| A8, Regulator Board | E7340-60016 | \$606 | Figure 6-2, Assembly location (see page 3 in this Service Note) |
| A12, GPIB-XF Board | E7340-60103 | \$591 | Figure 6-2, Assembly location (see page 3 in this Service Note) |
| A16, Leveling DAC Board | E7340-60094 | \$303 | Figure 6-2, Assembly location (see page 3 in this Service Note) |

This Service Note provides information on the frequently failed parts in the controller and mm heads of the 8510XF. Customers may want to buy spare parts now, since they may not be available after April 1, 2009.

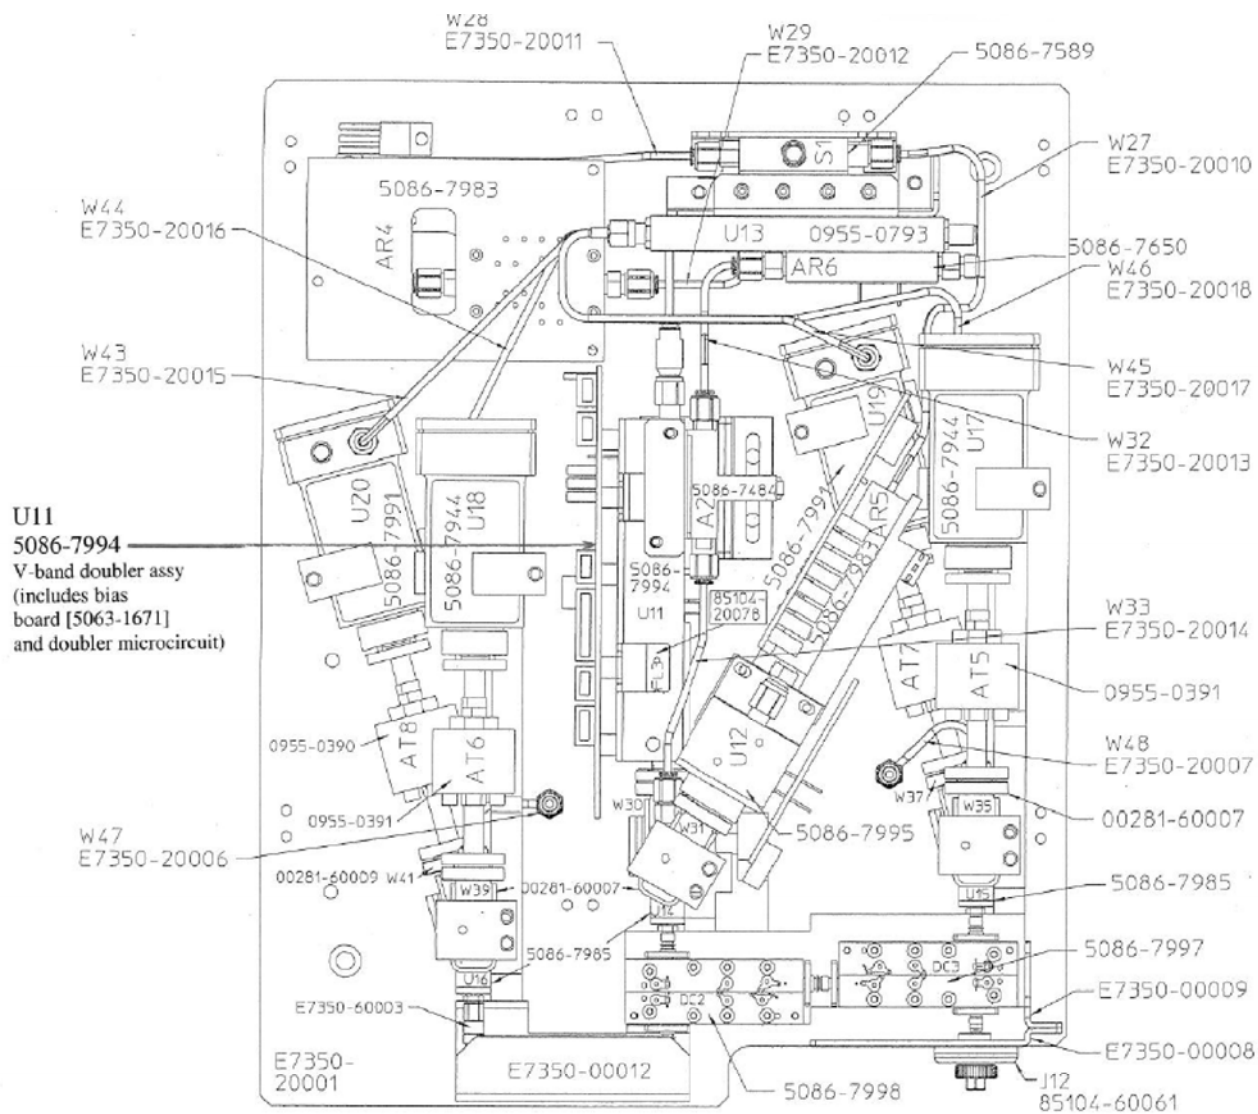
Bottom half of MM head

| <b>MM Controller</b> | <b>Part Number</b> | <b>Price</b> | <b>Reference</b> |
|---|---|---|---|
| Bias Board Assembly (see note below) | 5063-1671 | \$96.20 | See graphic of MM Head on page 4 in this Service Note |
| <b>Note:</b> U11, 5086-7994, V-band doubler includes Bias Board & Doubler assembly. | | | |
| Doubler assembly rarely fails but the bias board attached to it has high failure rate. | | | |
